ANSWERS AND MARKED UP TEXT

2. The Elbe River region in the Czech Republic and the city of Děčín

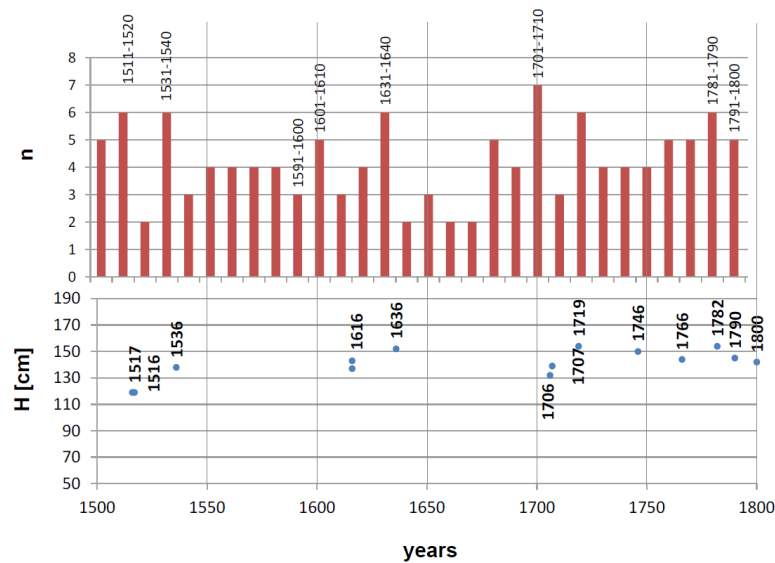
Fig. 5 Verification of marks of 1500-1800 according to the decade frequency of drought reports by Brázdil et al. (2013), n decadal frequencies of droughts, $H[cm]$ water level of DM.

From 1636 to 1707, i.e. for 70 years, there are no marks of minimum water levels. Brázdil et al. (2013) pointed out that the three decades of 1641-1650, 1661-1670 and 1671-1680 had a minimum decade occurrence of drought reports (2 cases per decade). Moreover, it is a period of the Maunder Minimum (Eddy, 1976), i.e. the 1640-1720 period, probably the most intensive period of the Little Ice Age (LIA).

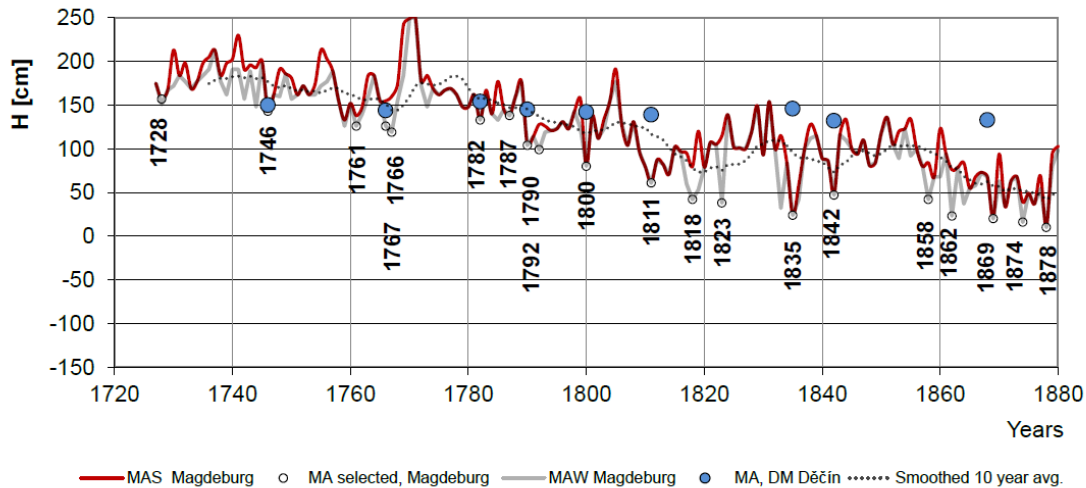
Fig. 6 Verification of marks in the period of 1727-1800 according to the annual (grey line) and summer (red line) minima of the Magdeburg 1727-1800 series with annual minima identified (and derived) from the marks on the HS3 hunger stone in Děčín (blue circles).

Since 1727, we have been able to identify the minima in the years highlighted in Fig. 6 with the help of the Magdeburg series. A very good time coincidence is apparent for 1746, 1766, 1782, 1790, 1800, 1811, 1835, 1842, 1858 and 1874. The year 1868 is missing, thus there is no representation of a deviating minimum in Magdeburg; however there is a significant mark later, in 1869. The year 1766 represents the only significant winter minimum which was marked on hunger stones. However, the winter minima of 1818, 1823 and 1862 are missing.

The water level DM minima are plotted in the water level scale of the current water gauge in Děčín. A coincidence regarding the water level (1746) is completely random (Fig. 6). However, there is a noticeable difference in the trend of annual lows of both series. We also emphasised the effect of the overall minima, so the graph also separates the winter minima, which show a downward trend, for example, just before 1746.

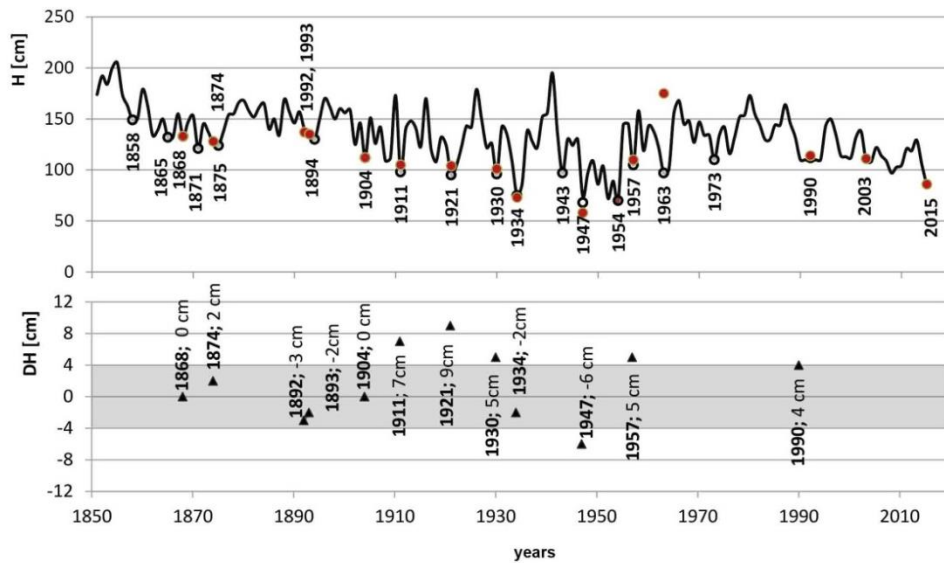
Fig. 7 Coincidence of annual water level minima at the Děčín station and altitudes measured on the HS and HS3 hunger stones in Děčín and Dolní Žleb. H is the water level. DH deviations are highlighted in the lower part of the graph. The precisely marked height (PMH) with deviations of 0-4cm is highlighted in grey, the outstanding marks are approximately marked heights (AMH) with deviations of 4-8 cm or more.

If we compare the results with the Děčín series, i.e. with direct measurements in the vicinity of the HS3 hunger stone, the deviations of the marked and measured annual values are minimal. Until 1957, there are 11-year lows (not counting local minima) which we can evaluate and 8 of them have a deviation of less than 4 cm. A result of less than 5 cm is detected for the marks from 1911 (+7), 1921 (+9), 1930 (+5), 1947 (-6 cm) and 1957 (+5) (see the graph in Fig. 7). In 1921, the local minimum was correctly marked; the annual minimum was not marked. The minima marked later, in 1963, 1981 (missing in the figure), 1990 and 2003 are not as important as the older extremes. In their origination, modern anthropogenic influences and partial misunderstandings of older traditions are manifested. This also applies to the prematurely made mark in Těchlovice. The 2003 mark is made well.

In conclusion, we can state a good match of the minima detected, which, moreover, are mostly representative of the largest extremes. However, this is not entirely true, as some years such as 1540, 1590 and 1761 are missing. This is a great motivation for the next stage of work.

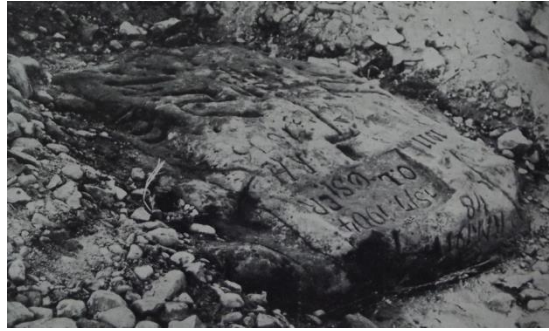
Fig. 8. Picture from *Český svět* magazine, No 51 dated 25 August 1911. It shows a completely unknown hunger stone. The following years are engraved: 1835, 1904, 1911, 1873 and 1(?)76 (1576, 1876 or 1516?). This picture was found in the National Museum archive by Zvonimír Dragoun. The locality is unknown and the existence is unverified.

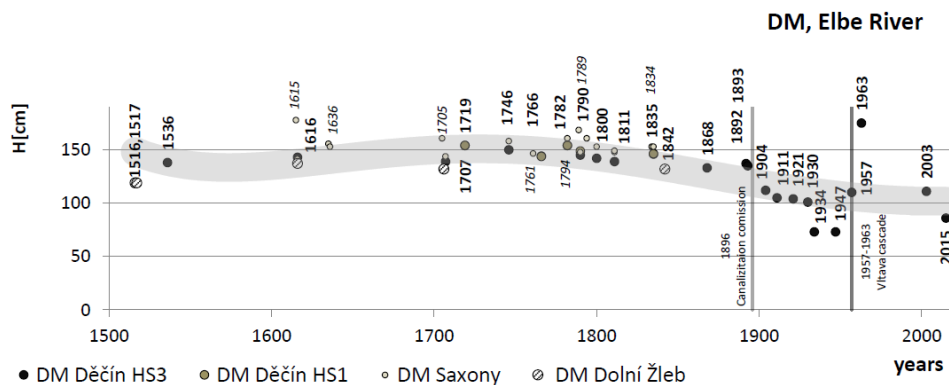
Fig. 9 Graphical overview of DM data from the Czech and Saxon areas (upper part). The **black and grey circles** represent the DM minima derived from the hunger stone in Děčín, the **hatched circles** relate to the stone in Dolní Žleb. This ensemble is completed by minima from the Saxon data (small circles), source (Table 9). The **grey line** highlights the trend of DM minima. Graphical overview of DM data from the Rhine basin (lower part). Water level minima derived from the Laufenstein DM (**black rectangles**), other epigraphic documentation (**hatched rectangles**) (Tables 11a, b).

A comparison of the duration of the tradition of making minimum markings in the Rhine and Elbe basins does not clearly indicate a longer tradition in either area. What is more interesting is a graphical overview of data from the Czech and Saxon DM sources (Fig. 9). It is apparent that the downward trend pointed out by reputed geographers and water managers (Burghaus, Grebenau, Wex, Harlacher and others) in the measured series has been apparent since about 1746, even at the lows recorded on hunger stones. In the case of Děčín, it is clear that during the coldest period of the LIA, the Maunder Minimum (Eddy, 1976) could have had a positive effect on the Elbe runoff, although, for example, Ogurtsov (2019) illustrates an even deeper minimum in the first half of the 15th century.
