## Reconstruction of track and simulation of storm surge associated with the calamitous typhoon affecting the Pearl River Estuary in September 1874

Hing Yim MOK, Wing Hong LUI, Dick Shum LAU, Wang Chun WOO

Hong Kong Observatory

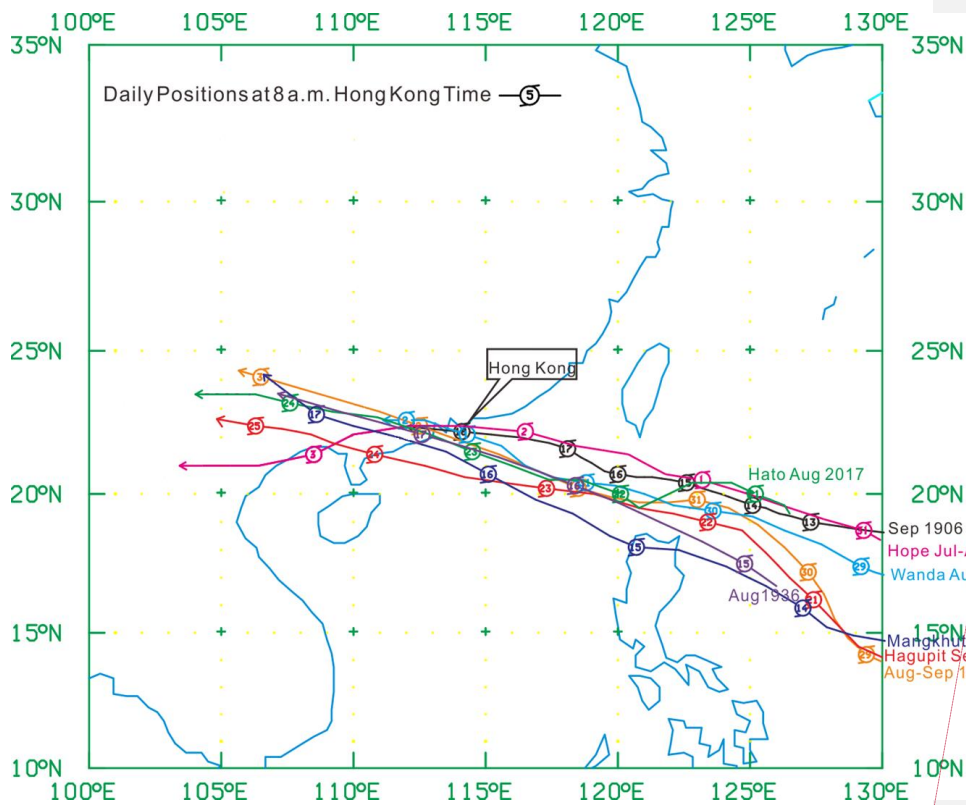
Figure 1. Daily positions at 8 a.m. Hong Kong Time of the typhoons affecting Hong Kong on 13-18 September 1906 (Typhoon Sep 1906), 15-17 August 1936 (Typhoon Aug 1936), 29 August to 3 September 1937 (Typhoon Aug-Sep 1937), Super Typhoon Wanda from 29 August to 2 September 1962 (Wanda Aug-Sep 1962), Super Typhoon Hope from 31 July to 3 August 1979 (Hope Jul-Aug 1979), Severe Typhoon Hagupit on 21-25 September 2008 (Hagupit Sep 2008), Super Typhoon Hato on 21-24 August 2017 (Hato Aug 2017) and Super Typhoon Mangkhut on 14-17 September 2018 (Mangkhut Sep 2018).

Hong Kong, located on the coast of southern China, is vulnerable to sea flooding due to storm surges associated with approaching tropical cyclones from the western North Pacific or the South China Sea. Since the establishment of the Hong Kong Observatory in 1883 when records of tropical cyclones affected Hong Kong began, storm surges induced by typhoons in 1906, 1937 and Super Typhoon<sup>3</sup> Wanda in 1962 brought severe casualties and damages to Hong Kong (Peterson, 1975; Ho, 2003). Storm surges induced by Super Typhoon Hope in 1979 (HKO, 1980), Severe Typhoon Hagupit in 2008 (HKO, 2009), Super Typhoon Hato in 2017 (<https://www.hko.gov.hk/informtc/hato17/hato.htm>; Lau & Chan, 2017) and  
40 Super Typhoon Mangkhut in 2018 (<https://www.hko.gov.hk/blog/en/archives/00000216.htm>), even though with no significant casualties, still brought severe flooding and damages to Hong Kong during their passages. Storm surge and sea level records, as well as the tracks of these typhoons, are shown in Table 1 and Figure 1 respectively.

Figure 1 shows that typhoons bringing significant storm surge impact to Hong Kong have similar tracks - forming and intensifying into at least typhoon strength over the western North Pacific, moving across the Luzon Strait without making  
50 landfall over the Philippines and Taiwan (except Mangkhut which skirted the northern part of Luzon), approaching the coast of Guangdong and making landfall over or passing to the south of Hong Kong. Typhoons moving across the Luzon Strait without making landfall over the Philippines and Taiwan can maintain their intensity, and making landfall over or passing to the south of Hong Kong will generate onshore winds that bring severe storm surges to the territory.

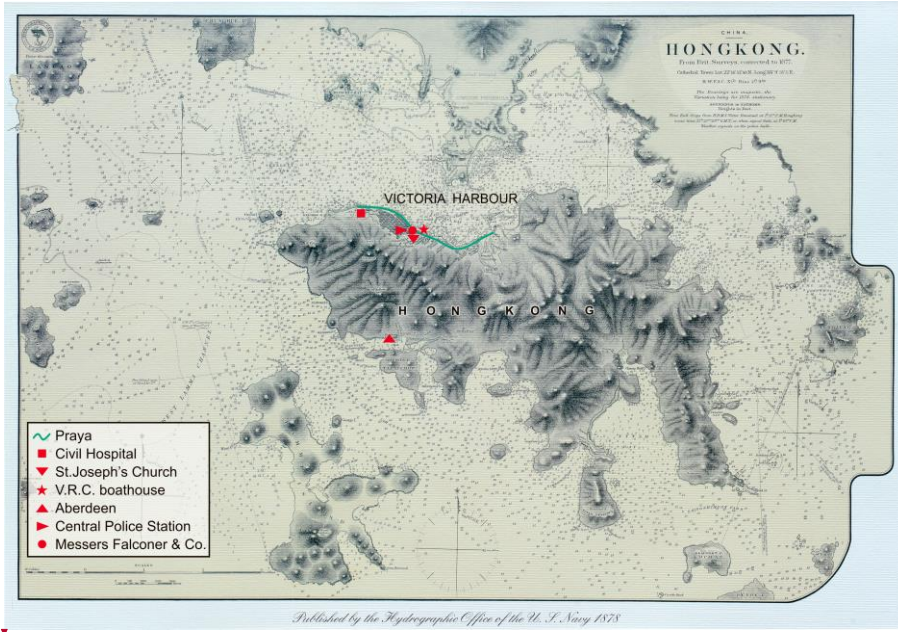
Figure 2. Historical Hong Kong map published by the Hydrographic Office of the U.K. Navy in 1878 (Courtesy of Mr. C. M. Shun), showing the Praya along the northern coast of the Hong Kong Island (shown in ~) and the locations of Civil Hospital (■), St. Joseph's Church (▼), V.R.C. boathouse (★), Aberdeen (▲), Central Police Station (▶) and Messers Falconer & Co (●) in the Hong Kong Island.

- (b) The Harbour Master Report in the Hong Kong Government Gazette on 17 October 1874 (Hong Kong Government, 1874) containing the qualitative observations of three ships (namely British ship Onward, American ship Highlander, German ship Amanda) on Typhoon 1874 near the then Pratas Shoal (now called Dongsha as marked in Figure 1) over the northeastern part of the South China Sea, description of the sequence of weather changes in the Victoria Harbour and pressure readings at the Central Police Station (the location is marked in Figure 2) in Hong Kong during the passage of Typhoon 1874;

- 150 (c) The China Mail of 23 September 1874 (China Mail, 1874) and Hong Kong Daily Press of 24 September 1874 (Hong Kong Daily Press, 1874) containing the pressure readings reduced to mean sea level in the Victoria Harbour from the Harbour Master and pressure readings recorded by two barometers of a local company, Messers Falconer & Co., in Hong Kong (the location is marked in Figure 2) during the passage of Typhoon 1874;

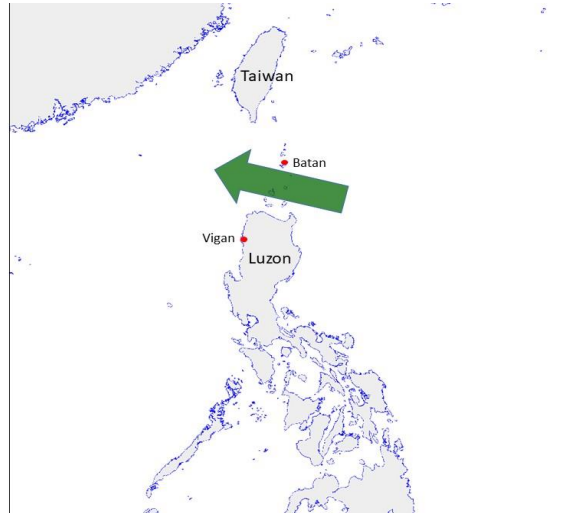
Figure 4. The possible track of Typhoon 1874 moving across the Luzon Strait between Batan and Vigan during the period from the evening on 21 September to the early morning on 22 September 1874.

Figure 4 shows the geographical location of Vigan and Batan Islands and Table 2 and Table 3 show the chronological summary of the meteorological observations at the two locations respectively based on the information in Annex I. It can be seen that Batan Islands and Vigan were affected by hurricane force winds from the east and west respectively at around midnight of 21 September, suggesting that the centre of Typhoon 1874 was passing through the area between Vigan and Batan Islands at about that time. As the pressure recorded at Batan Islands at

1 a.m. on 22 September (724 mmHg or 965.3 hPa) was much lower than that recorded at Vigan at midnight of 21 September (745 mmHg or 993.3 hPa), the centre of Typhoon 1874 was likely closer to Batan Islands than Vigan and located over the sea area off the coast of northern Luzon during its passage over the Luzon Strait, as indicated by the arrow in Figure 4.

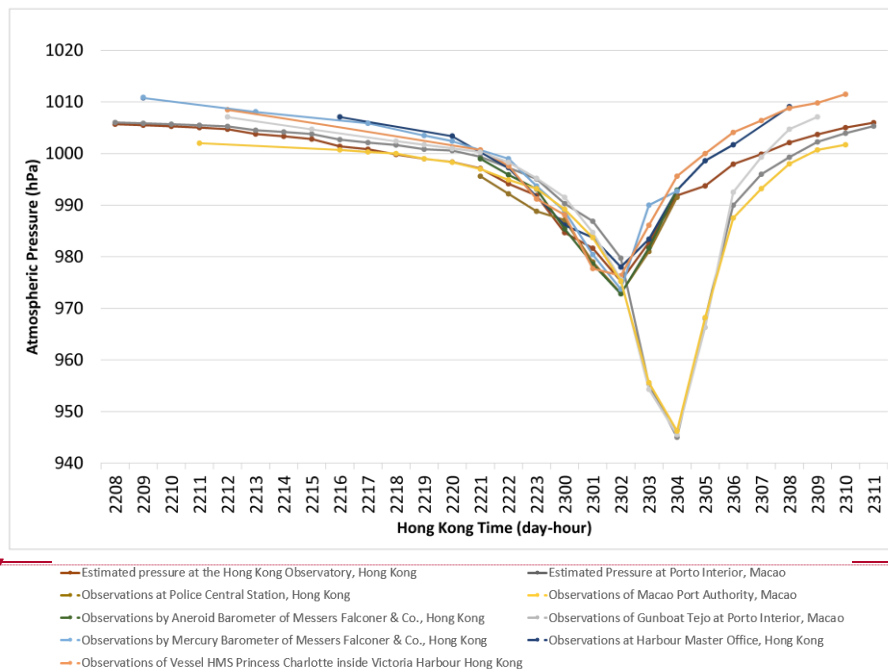
Figure 5. Series plots of pressure observations recorded at the Police Central Station, recorded by the Aneroid Barometer of Messers Falconer & Co., Hong Kong, the Mercury Barometer of Messers Falconer & Co., Hong Kong, Vessel HMS Princess Charlotte and Harbour Master Office in Hong Kong and recorded by the Macao Port Authority and Gunboat Tejo in Macao from 8 a.m. on 22 September to 11 a.m. on 23 September 1874 (as listed in Table 2) and the series plots of the atmospheric pressures at Hong Kong (Hong Kong Observatory) and Macao (Porto Interior) during the same period estimated by the Jelesnianski tropical cyclone model based on the hourly positions, hourly minimum mean sea level pressures near the centre and the radii of maximum wind of the reconstructed possible track as listed in Table 6.

A summary of the pressure observations in Hong Kong and Macao during the passage of Typhoon 1874 extracted from the available historical documents is shown in Table 4. Figure 5 plots the time series of those pressure observations from 8 a.m. on 22 September to 11 a.m. on 23 September 1874. It can be seen that the pressure at Hong Kong reached the minimum of around 975 hPa at 2 a.m. on 23 September while the pressure at Macao continued to fall to a minimum of around 946 hPa at 4 a.m. on 23 September. Furthermore, the pressure readings and pressure falling rate at Hong Kong and Macao were rather close with each other from the evening of 22 September to 2 a.m. on 23 September. This phenomenon revealed that Typhoon 1874 was at more or less the same distance from Hong Kong and Macao when it approached the Pearl River Estuary during this period.

Using the pressure observations in Hong Kong and Macao (Table 4 and Figure 5), and the Jelesnianski tropical cyclone model (Jelesnianski, 1965) shown in the equation below, given that Typhoon 1874 made landfall at Macao at 4 a.m. on 23 September with a minimum mean sea level pressure of 945 hPa near its centre, a possible track of Typhoon 1874 over the northeastern part of the South China Sea, particularly its passage along the coastal waters of eastern Guangdong and the Pearl River Estuary, can be reconstructed.

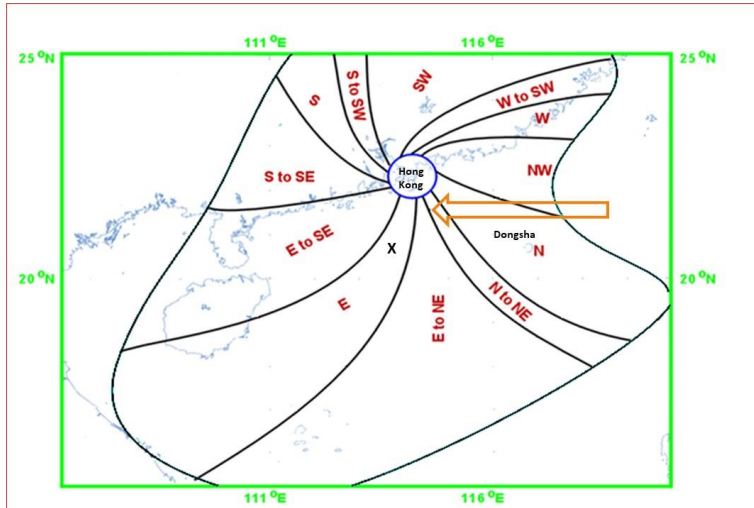
Figure 6. The 12-segment reference diagram showing the correlation between the wind direction at Waglan Island and tropical cyclone position during strong winds or above situations used by the Hong Kong Observatory. (For example, the winds at Waglan Island will be easterly when the tropical cyclone is located at position 'X'). The arrow framed in brown shows a typical track of tropical cyclone that could cause a sequential change of wind direction in Hong Kong similar to that of the passage of Typhoon 1874.

According to the result of a study on the relation between tropical cyclone position and wind direction at Waglan Island (an offshore island over the southeastern part of Hong Kong) during strong winds or above situations using tropical cyclones from 1968 to 2001 (Figure 6, Hong Kong Observatory), the sequence of wind direction change at Hong Kong during the passage of Typhoon 1874 suggested that Typhoon 1874 might most possibly approach Hong Kong from more or less the east and pass to the south of Hong Kong in the small hours on 23 September. This also provided further support for Typhoon 1874 passing to the north of Dongsha during its passage in the northeastern part of the South China Sea.

510 well with the observed wind direction changes at Hong Kong reported by the  
Harbour Master and HMS Princess Charlotte as shown in Table 5 during the  
approach and departure of the typhoon. Combining Figure 6 and Figure 7 could  
reveal that the wind direction at Hong Kong would veer gradually from  
northwesterly to northeasterly during the day on 22 September, and continue to  
veer to easterly and then southeasterly during the evening on 22 September and  
early morning of 23 September. Such sequence of wind direction change would  
not occur if the typhoon approached Hong Kong from the southeast or south  
during the day on 22 September. ▽

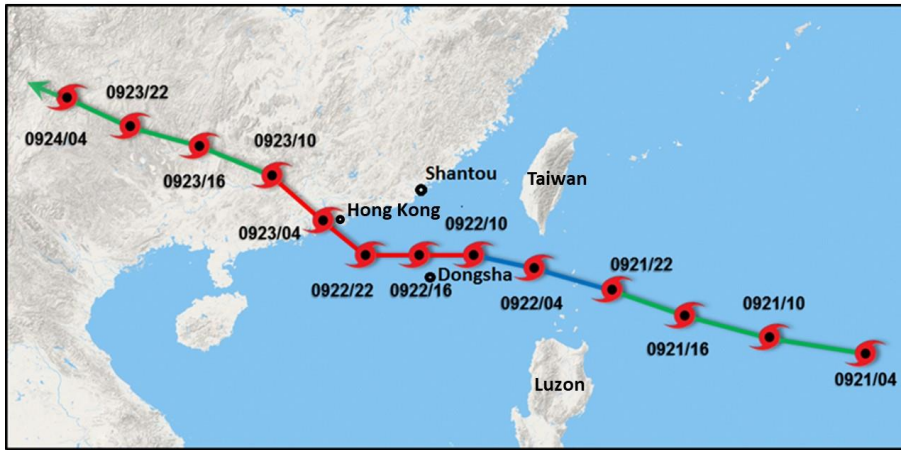
Figure 7 (a). The possible track of Typhoon 1874 passing through the Luzon Strait between Taiwan and Luzon and moving across the northern part of the South China Sea reconstructed in this study. Locations of Shantou and Dongsha are also shown.

Figure 7 (a) & (b) plot the possible track of Typhoon 1874 from the Luzon Strait to inland western Guangdong reconstructed in this study. In Figure 7(a), the part of the track in red was based on Table 6, the part in blue (in the morning on 22 September) was estimated by interpolation based on the qualitative analysis discussed in preceding session, and the parts in green were arbitrarily extended

to meet the requirement of input of thirteen 6-hourly positions for running the storm surge model for estimation of storm surges in Hong Kong and Macao. According to this reconstructed track, Typhoon 1874 might have moved at a high speed of about 38 km/h on average from the Luzon Strait to the Pearl River Estuary. It picked up a northwesterly track after 10 p.m. on 22 September when it was about 190 km southeast of Hong Kong to move towards the coast along a track with more or less the same distance from Hong Kong and Macao until 2 a.m. on 23 September when it was about 60 km south-southwest of Hong Kong, the closest approach to Hong Kong. The typhoon then took a slightly more westerly track to depart Hong Kong and moved towards Macao, resulting in a rapid rise in pressure at Hong Kong but continuing fall in pressure at Macao. The reconstructed track also reveals the intensification and decreasing in the storm size (the hurricane radius decreased from 200 km or larger near the Luzon Strait to around 70 km when making landfall at Macao) of the typhoon during its passage across the northeastern part of the South China Sea.

The 6-hourly positions, minimum mean sea level pressures near the centre and the radii of maximum winds of the reconstructed track of Typhoon 1874 in Figure 7(a) used for running SLOSH is shown in Table 7. It can be seen that Table 7 has included the position at 10 p.m. on 22 September when Typhoon 1874 started to pick up a northwesterly track and the position at 4 a.m. on 23 September when

Analysing the available weather records in historical documents, a possible track of Typhoon 1874 as shown in Figure 7(a) and Figure 7(b) was reconstructed in this study. It has to be noted that the parts of the reconstructed track over the western North Pacific and southwestern part of China (plotted in green in Figure 7(a)) were arbitrarily extended to meet the requirement of input of thirteen 6-hourly positions for running the storm surge model for estimation of storm surges in Hong Kong and Macao. The limited weather observations in the Luzon Strait area, though not sufficient enough to enable a detailed estimation of the positions of Typhoon 1874 moving over the Luzon Strait (plotted in blue in Figure 7(a)), have provided evidence that the typhoon had likely moved across the Luzon Strait between Vigan and Batan with typhoon intensity on the early morning of 22 September. For the reconstructed track over the northeastern part of the South China Sea, the Pearl River Estuary and western Guangdong (plotted in red in Figure 7(a) and the whole track in Figure 7(b)), a more quantitative and reliable estimation of the hourly positions, hourly minimum mean sea level pressures near the centre and the radii of maximum wind became possible by using the Jelesnianski tropical cyclone model based on the more comprehensive weather observations taken in Hong Kong and Macao. Besides reproducing the trends of change of atmospheric pressure with time at Hong Kong and Macao, including the rapid fall of atmospheric pressure at Macao from 2 a.m. to 4 a.m. on 23 September while the atmospheric pressure at Hong Kong was rising (Figure 5), the atmospheric pressure readings taken at Hong Kong and Macao could also be reproduced well. Comparing the hourly atmospheric pressures at Hong Kong and Macao during the period estimated by the Jelesnianski tropical cyclone model based on the hourly positions, hourly minimum mean sea level pressures near the centre and the hourly radii of maximum winds of Typhoon 1874 in Table 6 with

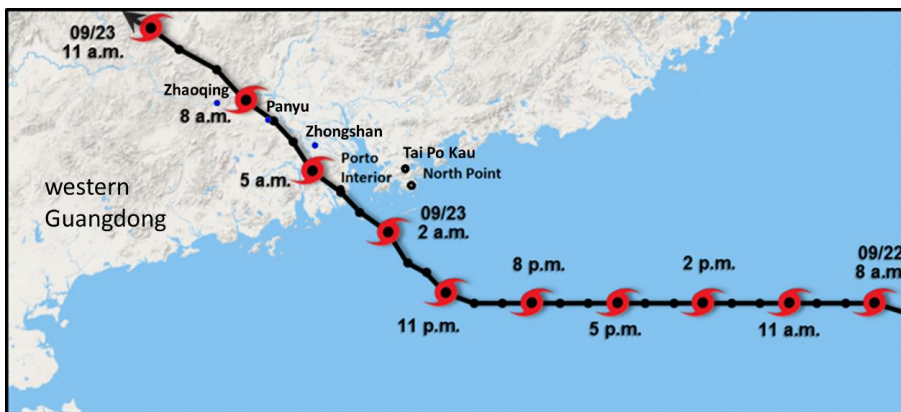
Figure 7 (b). The possible track of Typhoon 1874 moving along the coast of eastern Guangdong and the Pearl River Estuary reconstructed in this study. Locations of the tide gauges at North Point and Tai Po Kau in Hong Kong and Porto Interior in Macao, and locations of Zhongshan, Panyu and Zhaoqing in western Guangdong are also shown.

the typhoon made landfall at Macao. While locating maps of Hong Kong and Macao in the 1880's for obtaining the coastlines information might not be difficult, the bathymetry data with spatial resolution of about 1 km in Hong Kong and Macao waters and about 7 km in the open sea to the south of the Pearl River Estuary (the grid used for running SLOSH (Jelesnianski *et al.*, 1992)) in the 1880's would very likely be not available for running SLOSH. Instead, the earliest available digitized topographic and bathymetry information in the early 1990's were used for the estimation in this study. The maximum storm surges as estimated by SLOSH were 2.83 m (at 4:10 a.m. on 23 September) at North Point in the Victoria Harbour and 2.83 m (at 4:00 a.m. on 23 September) at Tai Po Kau in the northeastern part of Hong Kong where the tide gauges operated by the Hong Kong Observatory since the 1950s and 1960s respectively were located. In Macao, the maximum storm surge as estimated by SLOSH was 2.80 m (at 4:00 a.m. on 23 September) at Porto Interior where the tide gauge operated in Macao were located. Table 8 summarizes the estimated maximum storm surges at these three tide gauges. Locations of these three tide gauges are also marked in Figure 7 (b).

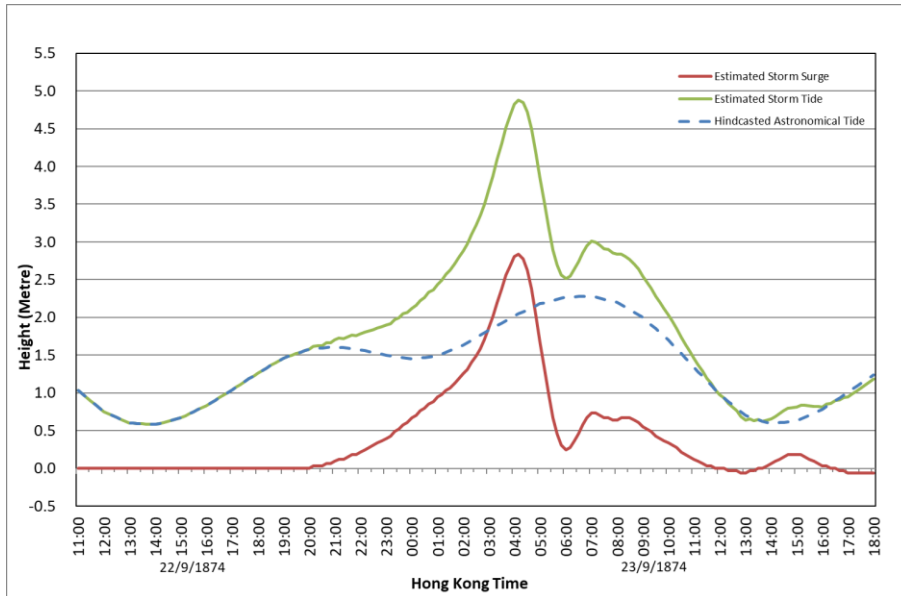
Figure 8. Time series of the hindcasted astronomical tide and estimated storm tide above Hong Kong Chart Datum and the estimated storm surge from 11 a.m. on 22 September to 6 p.m. on 23 September 1874 at North Point in Hong Kong. The estimated storm tide is the sum of the estimated storm surge and the astronomical tide.

Combining the estimated storm surges and hindcasted astronomical tides, the peak storm tides which are also shown in Table 8 were estimated to be 4.88 m above Hong Kong Chart Datum (at 4:10 a.m. on 23 September) at North Point, 4.95 m above Hong Kong Chart Datum (at 4:00 a.m. on 23 September) at Tai Po Kau and 5.37 m above Macao Chart Datum (at 4:00 a.m. on 23 September) at 440 Porto Interior in Macao. Figure 8, 9 and 10 plot the time series of the hindcasted astronomical tides, estimated storm surges and storm tides at North Point (Hong Kong), Tai Po Kau (Hong Kong) and Porto Interior (Macao) respectively from 11 a.m. on 22 September to 6 p.m. on 23 September 1874.

It can be seen that the hindcasted astronomical tide at North Point showed a low tide from midnight to around 2 a.m. on 23 September which was consistent with what the Harbour Master mentioned in his report in the Hong Kong Government Gazette of 17 October 1874 (The Hong Kong Government, 1874) – “Although, according to ordinary calculation it should have been low water at two o’clock”. Furthermore, given that the observations in the historical documents were taken 450 by human eyes at night time and not at the locations of the respective tide gauge stations, (a) the difference between the estimated storm tide of 3.69 m at 3 a.m. and the hindcasted astronomical high tide of 2.28 m at around 6:30 a.m. on 23 September at North Point (which was 1.41 m) was slightly lower than but comparable with the qualitative description of the rise in sea levels as recorded in the report of the Harbour Master in the Hong Kong Government Gazette of 17 October 1874 (The Hong Kong Government, 1874) – “By three, the water had risen to from five to six feet (equivalent to 1.52 m to 1.83 m) above its high water level” (meaning that the storm tide was 1.52 m to 1.83 m above the astronomical high tide in Hong Kong), and (b), the difference between the estimated maximum 460 storm tide of 5.37 m at 4 a.m. and the hindcasted astronomical high tide of 2.77

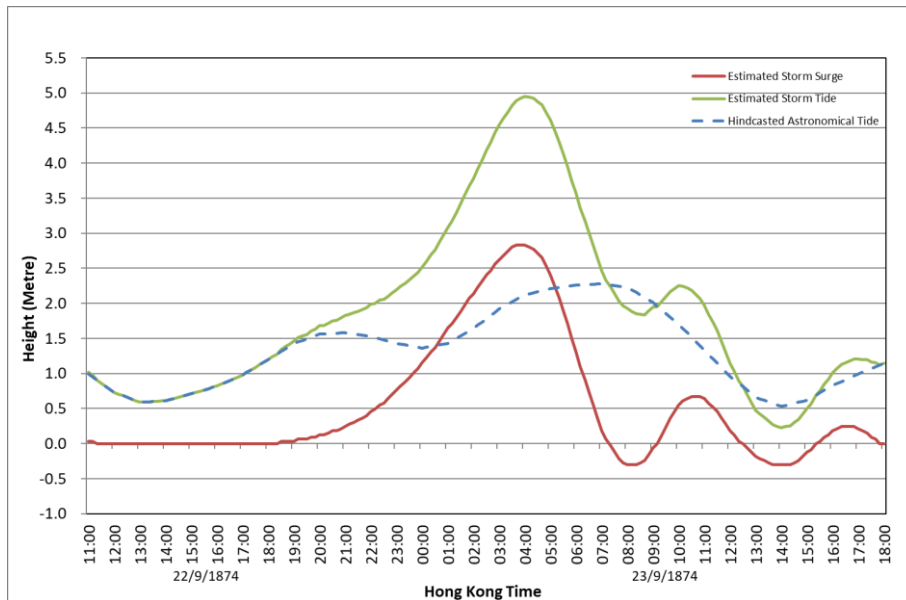
Figure 9. Time series of the hindcasted astronomical tide and estimated storm tide above Hong Kong Chart Datum and the estimated storm surge from 11 a.m. on 22 September to 6 p.m. on 23 September 1874 at Tai Po Kau in Hong Kong. The estimated storm tide is the sum of the estimated storm surge and the astronomical tide.

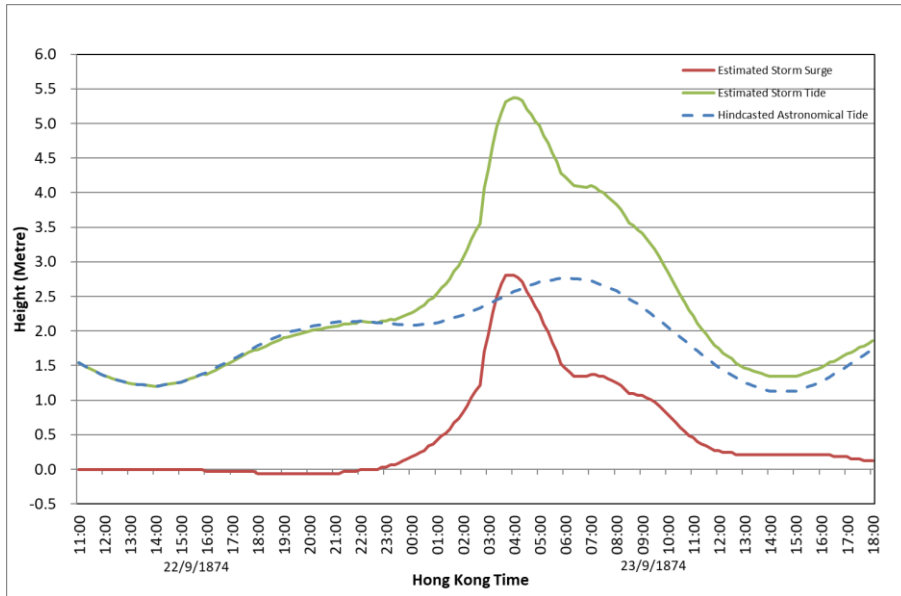
Figure 10. Time series of the hindcasted astronomical tide and estimated storm tide above Macao Chart Datum and the estimated storm surge from 11 a.m. on 22 September to 6 p.m. on 23 September 1874 at Porto Interior in Macao. The estimated storm tide is the sum of the estimated storm surge and the astronomical tide.

m at around 6 a.m. on 23 September at Porto Interior in Macao (which was 2.60 m) was slightly higher than but still considered comparable with the qualitative description of rise in sea levels as recorded in the publication “O Maior Tufao De Macau - 22 e 23 de Setembro de 1874” by Father Manuel Teixeira (1974) – “storm surge which caused severe flooding of up to 7 feet (equivalent to 2.13 m) above the high tide level” (meaning that the maximum storm tide was up to 2.13 m above the astronomical high tide in Macao).
