Reconstruction of track and simulation of storm surge associated with the calamitous typhoon affecting the Pearl River Estuary in September 1874

Hing Yim MOK, Wing Hong LUI, Dick Shum LAU, Wang Chun WOO

Hong Kong Observatory

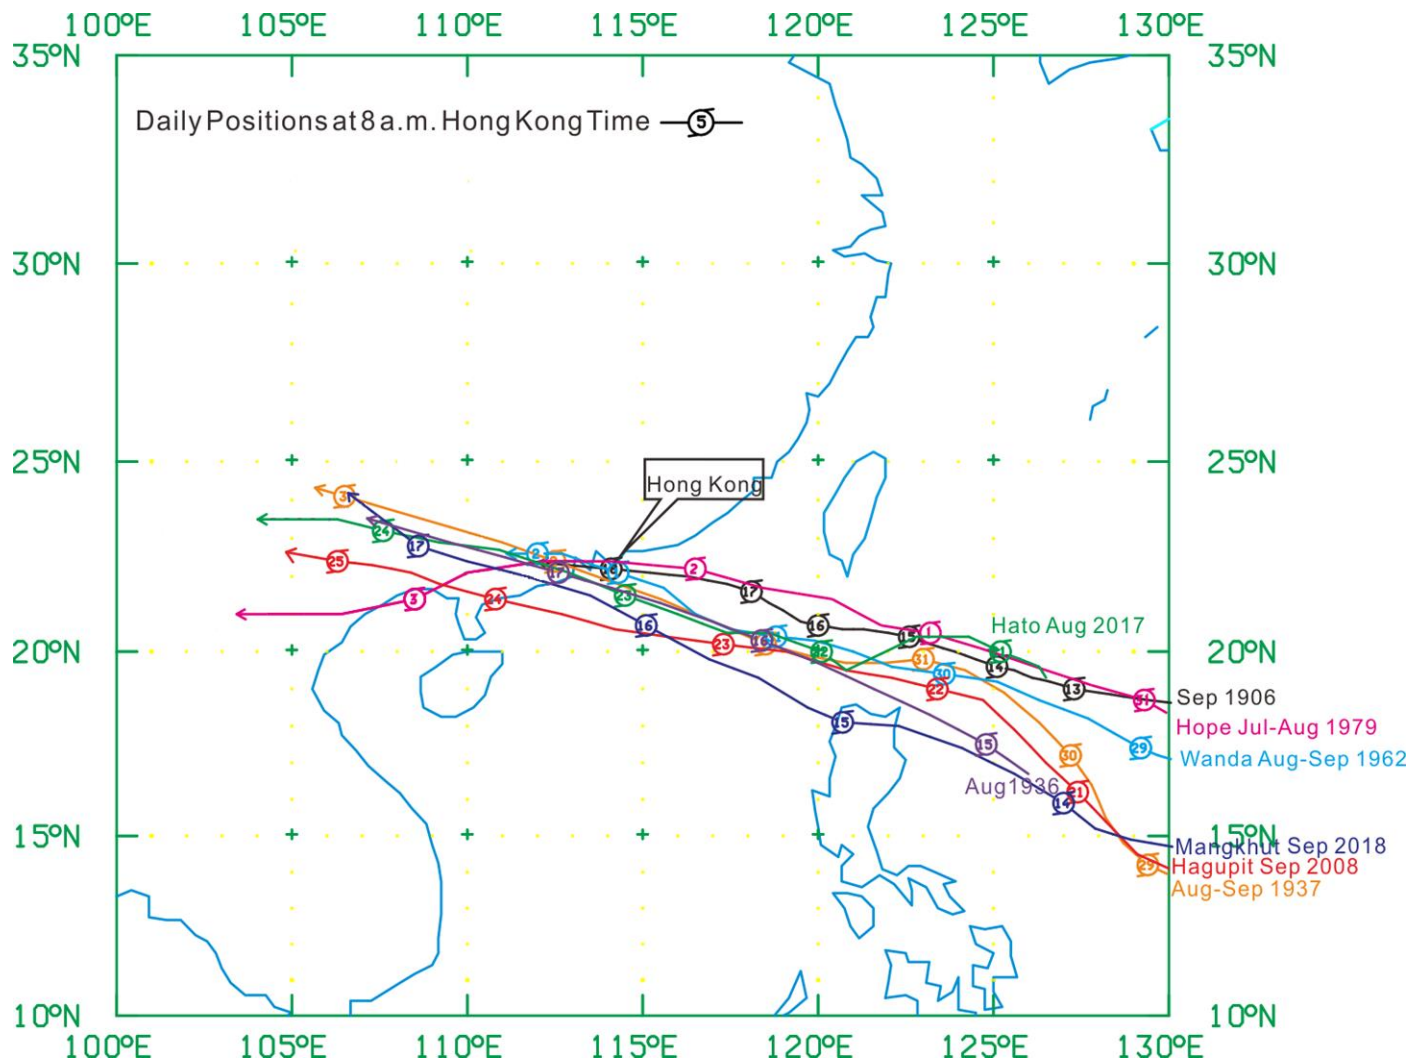
Figure 1. Daily positions at 8 a.m. Hong Kong Time of the typhoons affecting Hong Kong on 13-18 September 1906 (Typhoon Sep 1906), 15-17 August 1936 (Typhoon Aug 1936), 29 August to 3 September 1937 (Typhoon Aug-Sep 1937), Super Typhoon Wanda from 29 August to 2 September 1962 (Wanda Aug-Sep 1962), Super Typhoon Hope from 31 July to 3 August 1979 (Hope Jul-Aug 1979), Severe Typhoon Hagupit on 21-25 September 2008 (Hagupit Sep 2008), Super Typhoon Hato on 21-24 August 2017 (Hato Aug 2017) and Super Typhoon Mangkhut on 14-17 September 2018 (Mangkhut Sep 2018).

Hong Kong, located on the coast of southern China, is vulnerable to sea flooding due to storm surges associated with approaching tropical cyclones from the western North Pacific or the South China Sea. Since the establishment of the Hong Kong Observatory in 1883 when records of tropical cyclones affected Hong Kong began, storm surges induced by typhoons in 1906, 1937 and Super Typhoon³ Wanda in 1962 brought severe casualties and damages to Hong Kong (Peterson, 1975; Ho, 2003). Storm surges induced by Super Typhoon Hope in 1979 (HKO, 1980), Severe Typhoon Hagupit in 2008 (HKO, 2009), Super Typhoon Hato in 2017 (<https://www.hko.gov.hk/informtc/hato17/hato.htm>; Lau & Chan, 2017) and
40 Super Typhoon Mangkhut in 2018 (<https://www.hko.gov.hk/blog/en/archives/00000216.htm>), even though with no significant casualties, still brought severe flooding and damages to Hong Kong during their passages. Storm surge and sea level records, as well as the tracks of these typhoons, are shown in Table 1 and Figure 1 respectively.

Figure 1 shows that typhoons bringing significant storm surge impact to Hong Kong have similar tracks - forming and intensifying into at least typhoon strength over the western North Pacific, moving across the Luzon Strait without making landfall over the Philippines and Taiwan (except Mangkhut which skirted the
50 northern part of Luzon), approaching the coast of Guangdong and making landfall over or passing to the south of Hong Kong. Typhoons moving across the Luzon Strait without making landfall over the Philippines and Taiwan can maintain their intensity, and making landfall over or passing to the south of Hong Kong will generate onshore winds that bring severe storm surges to the territory.

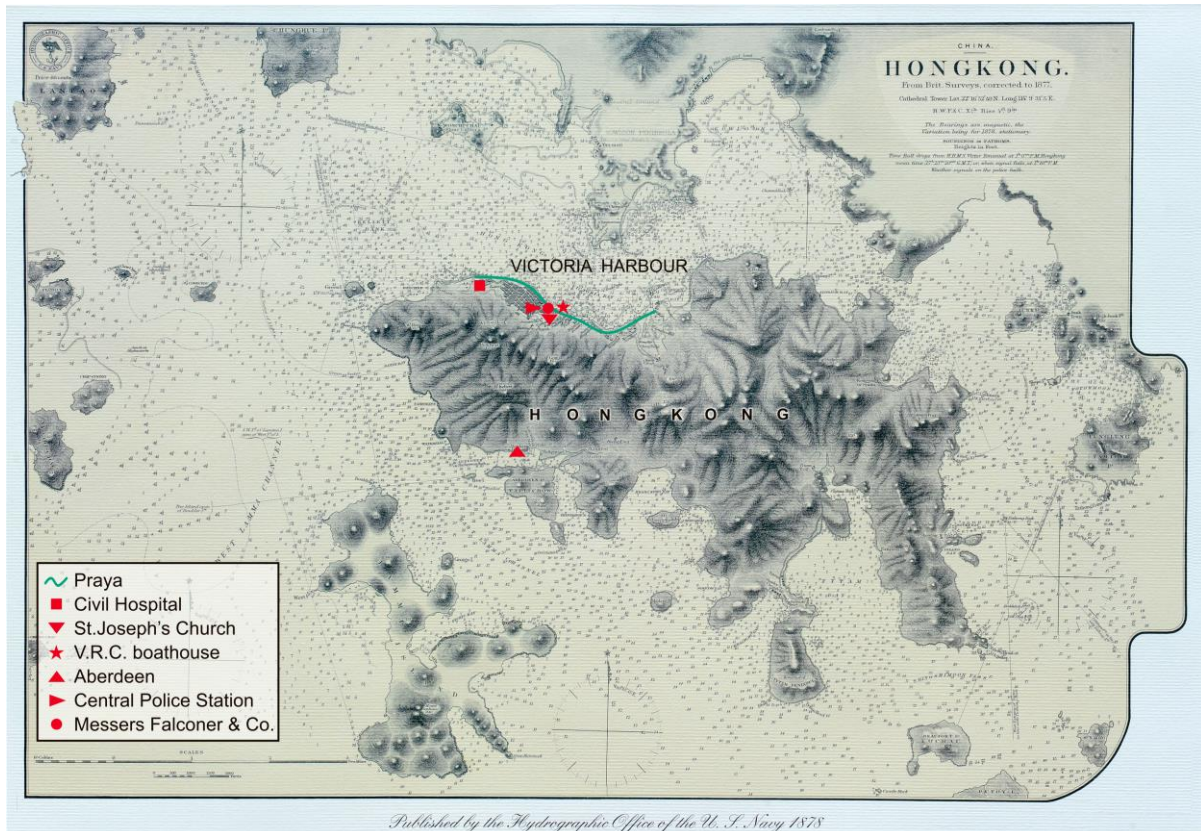
Figure 2. Historical Hong Kong map published by the Hydrographic Office of the U.K. Navy in 1878 (Courtesy of Mr. C. M. Shun), showing the Praya along the northern coast of the Hong Kong Island (shown in ~) and the locations of Civil Hospital (■), St. Joseph's Church (▼), V.R.C. boathouse (★), Aberdeen (▲), Central Police Station (►) and Messers Falconer & Co (●) in the Hong Kong Island.

(the official weather authority in Hong Kong) later in 1883. “Hong Kong Typhoons” (Heywood, 1950) recorded that “the typhoon demolished the Civil Hospital and St. Joseph’s Church (the locations are marked in Figure 2). A warship dragged her moorings and was thrown into V.R.C. boathouse (the location is marked in Figure 2)”. As described in the report by the Captain Superintendent of Police (Hong Kong Government, 1874), “The Police had recovered the bodies of 621 people, but this number probably represented only one third of the actual figure. Furthermore, over 200 houses were destroyed or rendered uninhabitable. Two steamers sank in the harbour and another steamer was on shore near
70 Aberdeen (the location is marked in Figure 2), and eight ships were supposed to have been lost. It was impossible to estimate the destruction of junks and small boats. Telegraph posts were blown down in different parts of the Hong Kong Island, interrupting communications. The roads were almost impassable from the obstruction caused by the fallen trees.” The China Mail of 23 September 1874 (China Mail, 1874) also reported that “A typhoon, though of very short duration, has probably proved the most destructive witnessed since 1862 – if not exceeding it in that respect - swept over the island between the hours of 6 p.m. and 6 a.m.”.

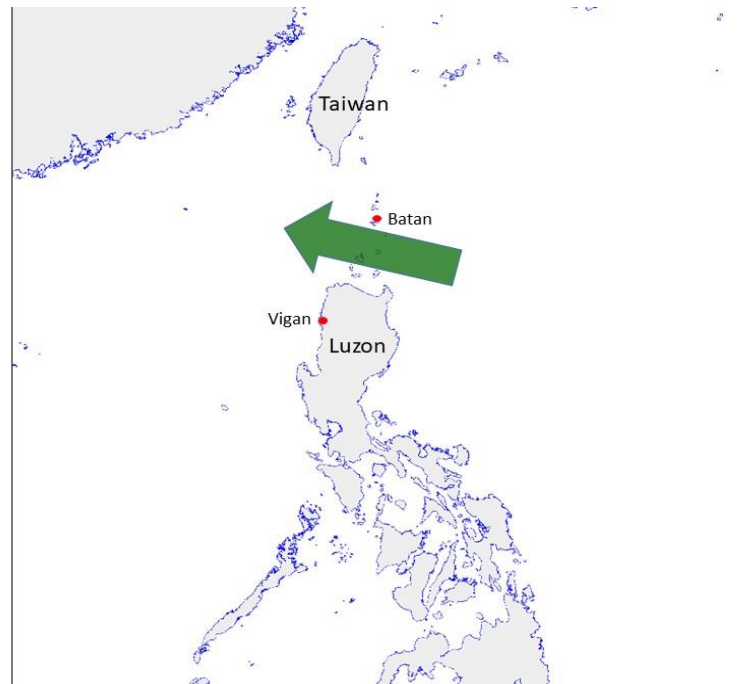
Figure 4. The possible track of Typhoon 1874 moving across the Luzon Strait between Batan and Vigan during the period from the evening on 21 September to the early morning on 22 September 1874.

Figure 4 shows the geographical location of Vigan and Batan Islands and Table 2 and Table 3 show the chronological summary of the meteorological observations at the two locations respectively based on the information in Annex I. It can be seen that Batan Islands and Vigan were affected by hurricane force winds from the east and west respectively at around midnight of 21 September, suggesting that the centre of Typhoon 1874 was passing through the area between Vigan and Batan Islands at about that time. As the pressure recorded at Batan Islands at

1 a.m. on 22 September (724 mmHg or 965.3 hPa) was much lower than that recorded at Vigan at midnight of 21 September (745 mmHg or 993.3 hPa), the centre of Typhoon 1874 was likely closer to Batan Islands than Vigan and located over the sea area off the coast of northern Luzon during its passage over the Luzon Strait, as indicated by the arrow in Figure 4.

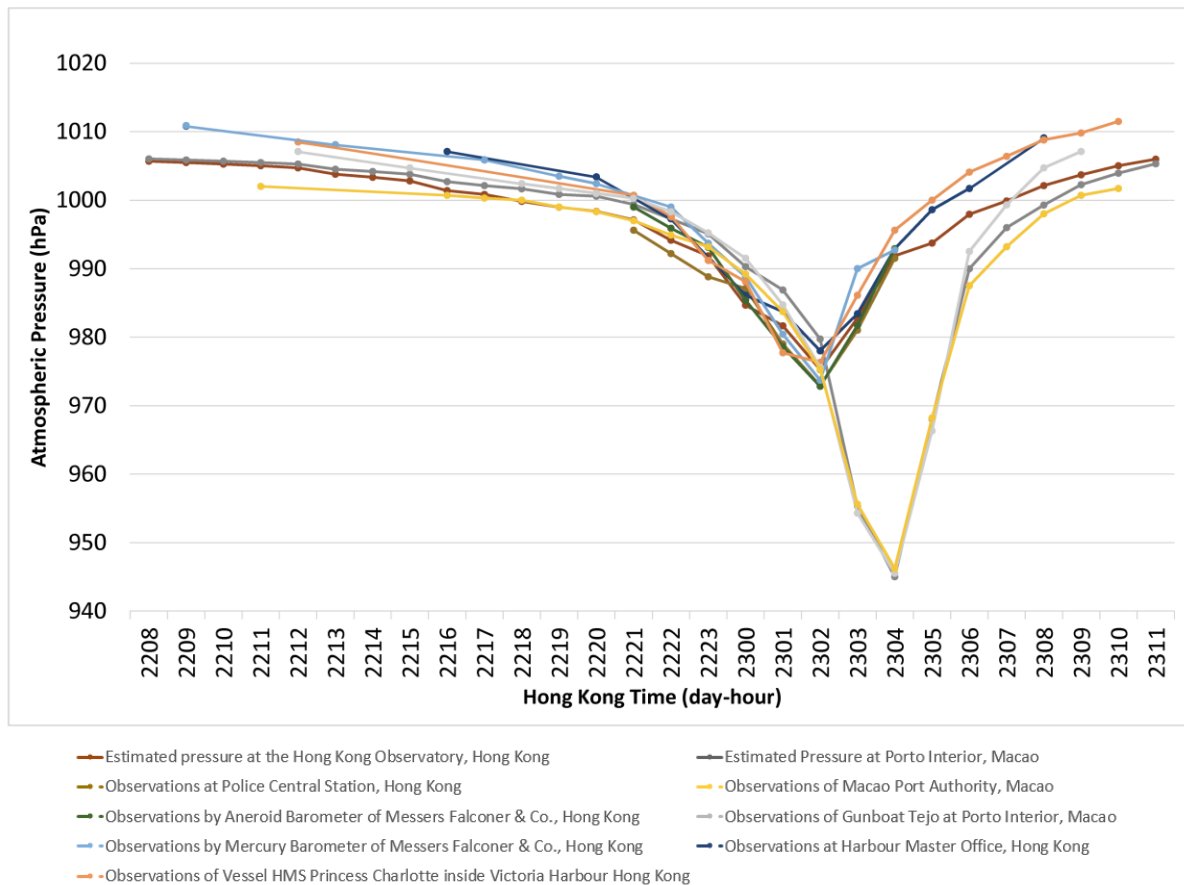
Figure 5. Series plots of pressure observations recorded at the Police Central Station, recorded by the Aneroid Barometer of Messers Falconer & Co., Hong Kong, the Mercury Barometer of Messers Falconer & Co., Hong Kong, Vessel HMS Princess Charlotte and Harbour Master Office in Hong Kong and recorded by the Macao Port Authority and Gunboat Tejo in Macao from 8 a.m. on 22 September to 11 a.m. on 23 September 1874 (as listed in Table 2) and the series plots of the atmospheric pressures at Hong Kong (Hong Kong Observatory) and Macao (Porto Interior) during the same period estimated by the Jelesnianski tropical cyclone model based on the hourly positions, hourly minimum mean sea level pressures near the centre and the radii of maximum wind of the reconstructed possible track as listed in Table 6.

A summary of the pressure observations in Hong Kong and Macao during the passage of Typhoon 1874 extracted from the available historical documents is shown in Table 4. Figure 5 plots the time series of those pressure observations from 8 a.m. on 22 September to 11 a.m. on 23 September 1874. It can be seen that the pressure at Hong Kong reached the minimum of around 975 hPa at 2 a.m. on 23 September while the pressure at Macao continued to fall to a minimum of around 946 hPa at 4 a.m. on 23 September. Furthermore, the pressure readings and pressure falling rate at Hong Kong and Macao were rather close with each other from the evening of 22 September to 2 a.m. on 23 September. This phenomenon revealed that Typhoon 1874 was at more or less the same distance from Hong Kong and Macao when it approached the Pearl River Estuary during this period.

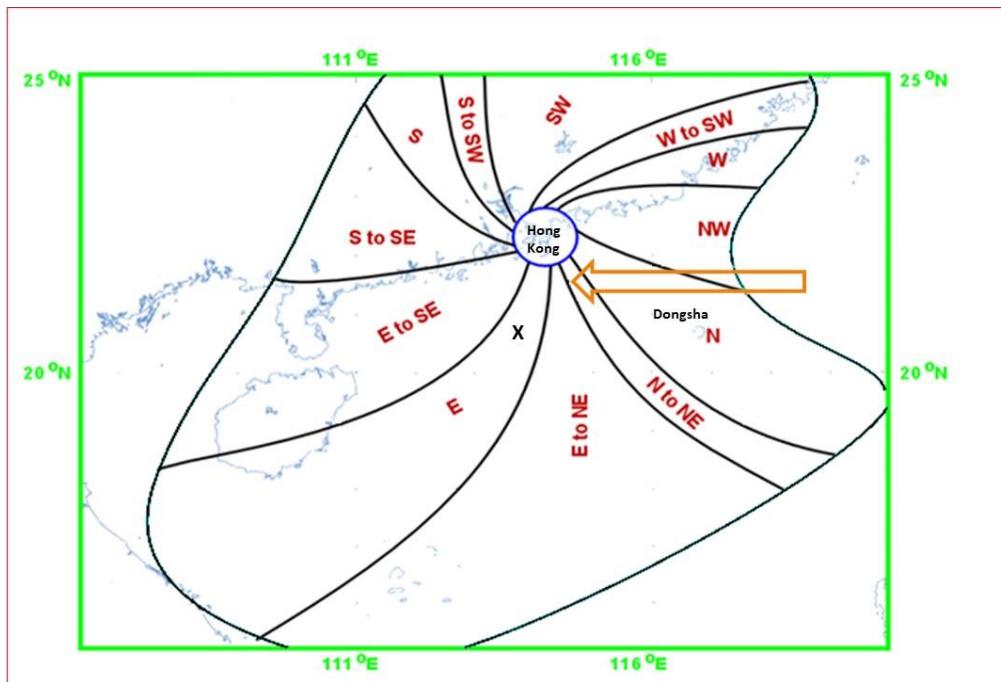
Figure 6. The 12-segment reference diagram showing the correlation between the wind direction at Waglan Island and tropical cyclone position during strong winds or above situations used by the Hong Kong Observatory (For example, the winds at Waglan Island will be easterly when the tropical cyclone is located at position 'X'). The arrow framed in brown shows a typical track of tropical cyclone that could cause a sequential change of wind direction in Hong Kong similar to that of the passage of Typhoon 1874.

According to the result of a study on the relation between tropical cyclone position and wind direction at Waglan Island (an offshore island over the southeastern part of Hong Kong) during strong winds or above situations using tropical cyclones from 1968 to 2001 (Figure 6, Hong Kong Observatory), the sequence of wind direction change at Hong Kong during the passage of Typhoon 1874 suggested that Typhoon 1874 might most possibly approach Hong Kong from more or less the east and pass to the south of Hong Kong in the small hours on 23 September. This also provided further support for Typhoon 1874 passing to the north of Dongsha during its passage in the northeastern part of the South China Sea.

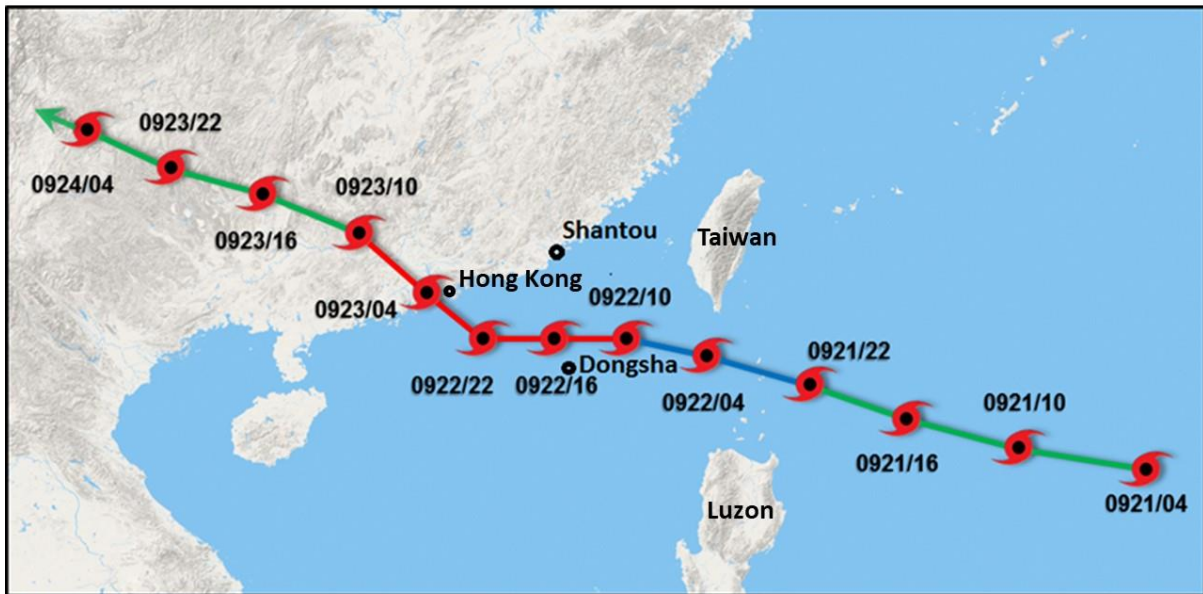
Figure 7 (a). The possible track of Typhoon 1874 passing through the Luzon Strait between Taiwan and Luzon and moving across the northern part of the South China Sea reconstructed in this study. Locations of Shantou and Dongsha are also shown.

Figure 7 (a) & (b) plot the possible track of Typhoon 1874 from the Luzon Strait to inland western Guangdong reconstructed in this study. In Figure 7(a), the part of the track in red was based on Table 6, the part in blue (in the morning on 22 September) was estimated by interpolation based on the qualitative analysis discussed in preceding session, and the parts in green were arbitrarily extended

The 6-hourly positions, minimum mean sea level pressures near the centre and the radii of maximum winds of the reconstructed track of Typhoon 1874 in Figure 7(a) used for running SLOSH is shown in Table 7. It can be seen that Table 7 has included the position at 10 p.m. on 22 September when Typhoon 1874 started to pick up a northwesterly track and the position at 4 a.m. on 23 September when

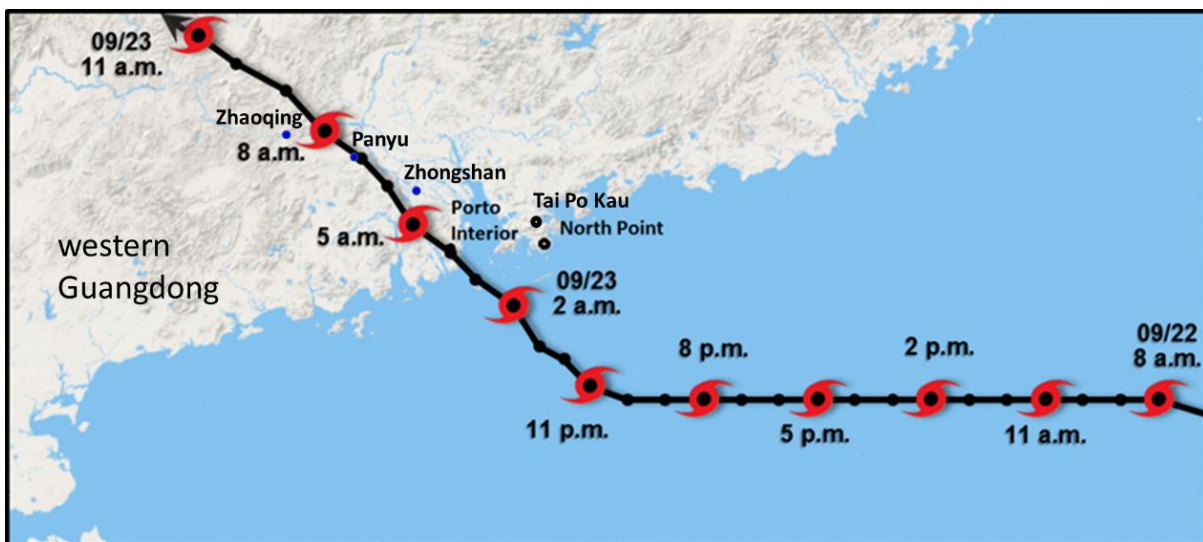
Figure 7 (b). The possible track of Typhoon 1874 moving along the coast of eastern Guangdong and the Pearl River Estuary reconstructed in this study. Locations of the tide gauges at North Point and Tai Po Kau in Hong Kong and Porto Interior in Macao, and locations of Zhongshan, Panyu and Zhaoqing in western Guangdong are also shown.

the typhoon made landfall at Macao. While locating maps of Hong Kong and Macao in the 1880's for obtaining the coastlines information might not be difficult, the bathymetry data with spatial resolution of about 1 km in Hong Kong and Macao waters and about 7 km in the open sea to the south of the Pearl River Estuary (the grid used for running SLOSH (Jelesnianski *et al.*, 1992)) in the 1880's would very likely be not available for running SLOSH. Instead, the earliest available digitized topographic and bathymetry information in the early 1990's were used for the estimation in this study. The maximum storm surges as estimated by SLOSH were 2.83 m (at 4:10 a.m. on 23 September) at North Point in the Victoria Harbour and 2.83 m (at 4:00 a.m. on 23 September) at Tai Po Kau in the northeastern part of Hong Kong where the tide gauges operated by the Hong Kong Observatory since the 1950s and 1960s respectively were located. In Macao, the maximum storm surge as estimated by SLOSH was 2.80 m (at 4:00 a.m. on 23 September) at Porto Interior where the tide gauge operated in Macao were located. Table 8 summarizes the estimated maximum storm surges at these three tide gauges. Locations of these three tide gauges are also marked in Figure 7 (b).

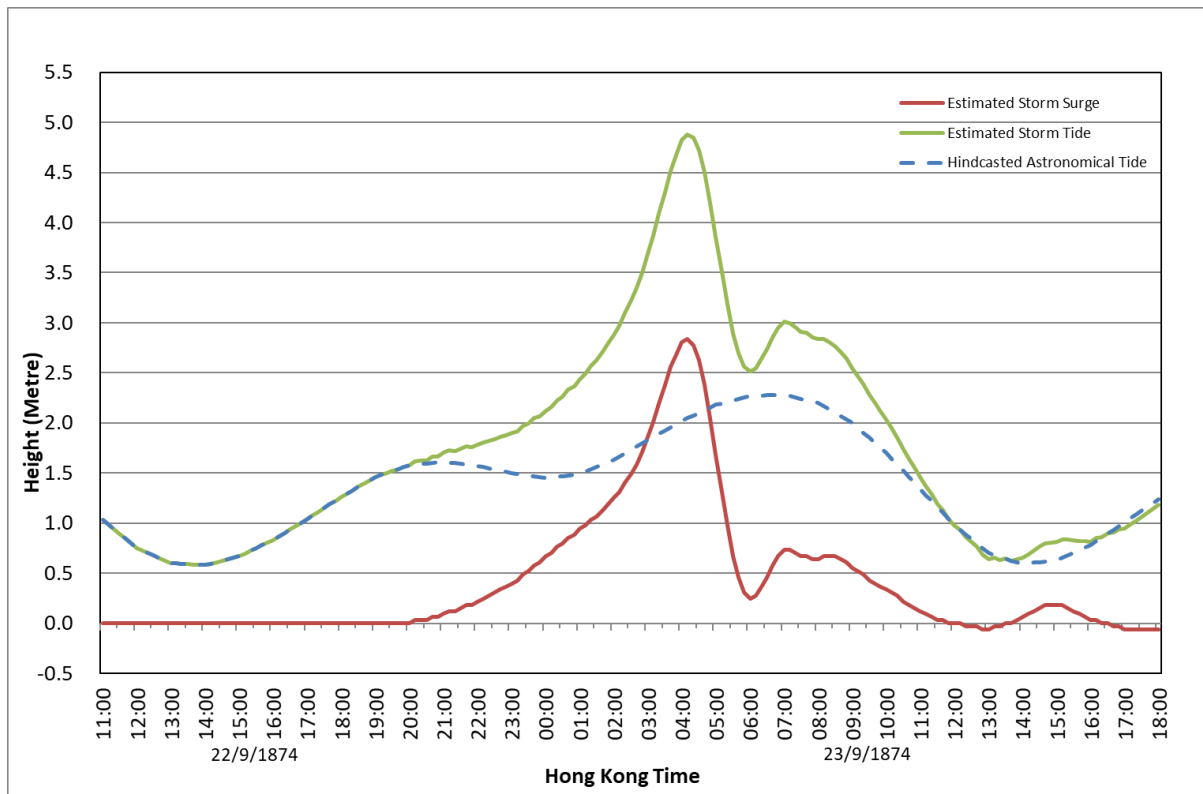
Figure 8. Time series of the hindcasted astronomical tide and estimated storm tide above Hong Kong Chart Datum and the estimated storm surge from 11 a.m. on 22 September to 6 p.m. on 23 September 1874 at North Point in Hong Kong. The estimated storm tide is the sum of the estimated storm surge and the astronomical tide.

400 Combining the estimated storm surges and hindcasted astronomical tides, the peak storm tides which are also shown in Table 8 were estimated to be 4.88 m above Hong Kong Chart Datum (at 4:10 a.m. on 23 September) at North Point, 4.95 m above Hong Kong Chart Datum (at 4:00 a.m. on 23 September) at Tai Po Kau and 5.37 m above Macao Chart Datum (at 4:00 a.m. on 23 September) at Porto Interior in Macao. Figure 8, 9 and 10 plot the time series of the hindcasted astronomical tides, estimated storm surges and storm tides at North Point (Hong Kong), Tai Po Kau (Hong Kong) and Porto Interior (Macao) respectively from 11 a.m. on 22 September to 6 p.m. on 23 September 1874.

410 It can be seen that the hindcasted astronomical tide at North Point showed a low tide from midnight to around 2 a.m. on 23 September which was consistent with what the Harbour Master mentioned in his report in the Hong Kong Government Gazette of 17 October 1874 (The Hong Kong Government, 1874) – “Although, according to ordinary calculation it should have been low water at two o’clock”. Furthermore, given that the observations in the historical documents were taken by human eyes at night time and not at the locations of the respective tide gauge stations, (a) the difference between the estimated storm tide of 3.69 m at 3 a.m. and the hindcasted astronomical high tide of 2.28 m at around 6:30 a.m. on 23 September at North Point (which was 1.41 m) was slightly lower than but comparable with the qualitative description of the rise in sea levels as recorded in
420 the report of the Harbour Master in the Hong Kong Government Gazette of 17 October 1874 (The Hong Kong Government, 1874) – “By three, the water had risen to from five to six feet (equivalent to 1.52 m to 1.83 m) above its high water level” (meaning that the storm tide was 1.52 m to 1.83 m above the astronomical high tide in Hong Kong), and (b) the difference between the estimated maximum storm tide of 5.37 m at 4 a.m. and the hindcasted astronomical high tide of 2.77

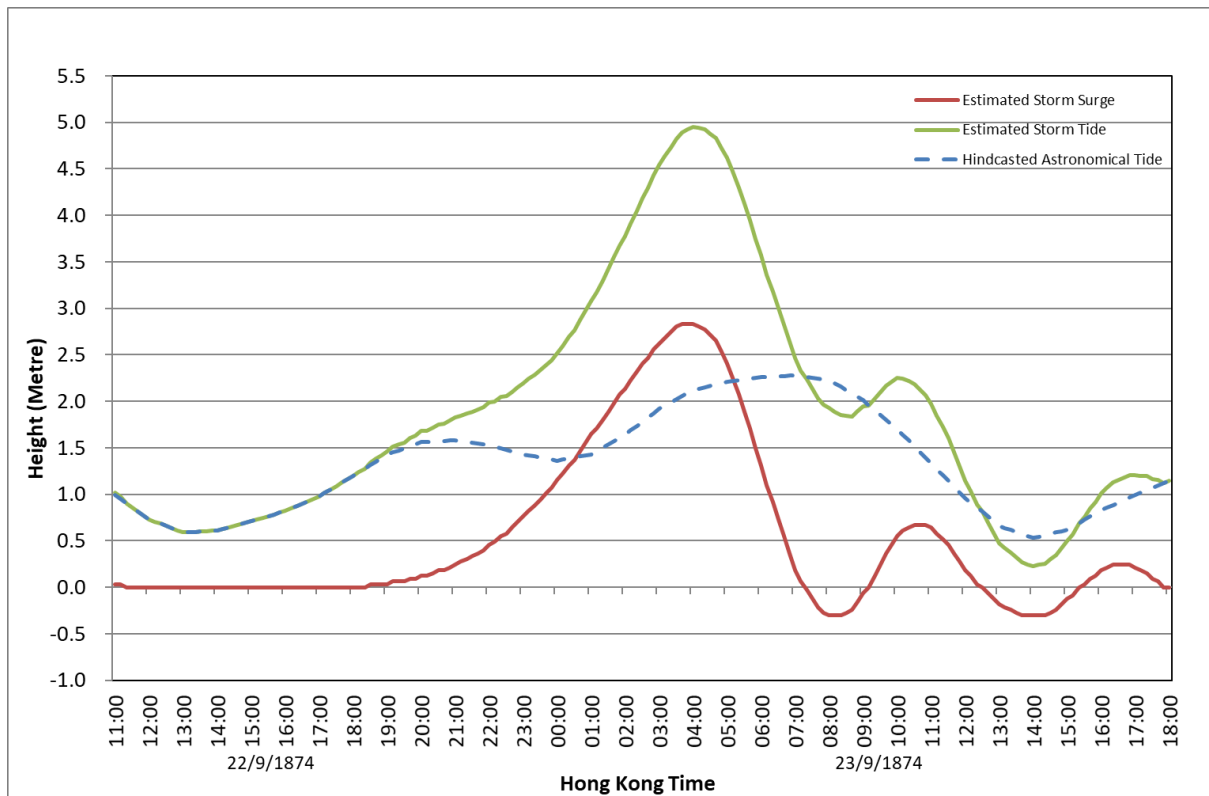
Figure 9. Time series of the hindcasted astronomical tide and estimated storm tide above Hong Kong Chart Datum and the estimated storm surge from 11 a.m. on 22 September to 6 p.m. on 23 September 1874 at Tai Po Kau in Hong Kong. The estimated storm tide is the sum of the estimated storm surge and the astronomical tide.

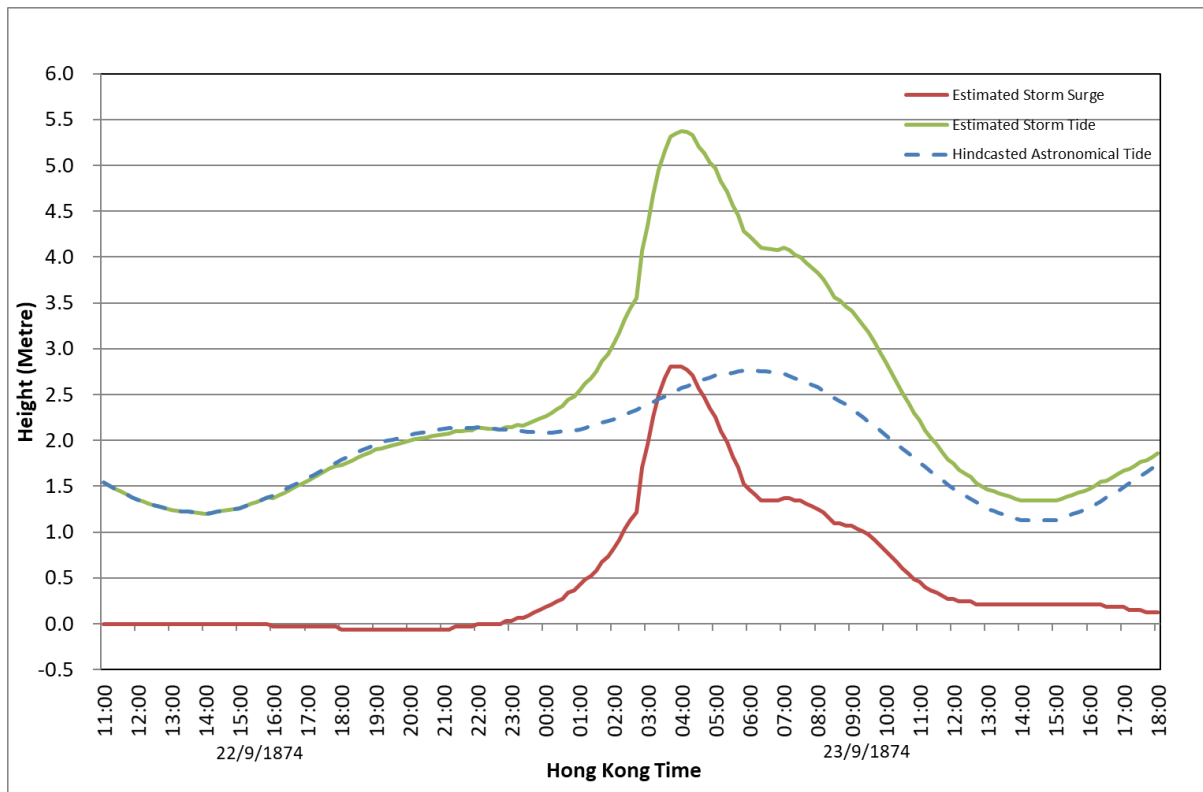
Figure 10. Time series of the hindcasted astronomical tide and estimated storm tide above Macao Chart Datum and the estimated storm surge from 11 a.m. on 22 September to 6 p.m. on 23 September 1874 at Porto Interior in Macao. The estimated storm tide is the sum of the estimated storm surge and the astronomical tide.

m at around 6 a.m. on 23 September at Porto Interior in Macao (which was 2.60 m) was slightly higher than but still considered comparable with the qualitative description of rise in sea levels as recorded in the publication “O Maior Tufao De Macau - 22 e 23 de Setembro de 1874” by Father Manuel Teixeira (1974) – “storm surge which caused severe flooding of up to 7 feet (equivalent to 2.13 m) above the high tide level” (meaning that the maximum storm tide was up to 2.13 m above the astronomical high tide in Macao).
