## Reconstruction of track and simulation of storm surge associated with the calamitous typhoon affecting the Pearl River Estuary in September 1874

Hing Yim MOK, Wing Hong LUI, Dick Shum LAU, Wang Chun WOO

Hong Kong Observatory

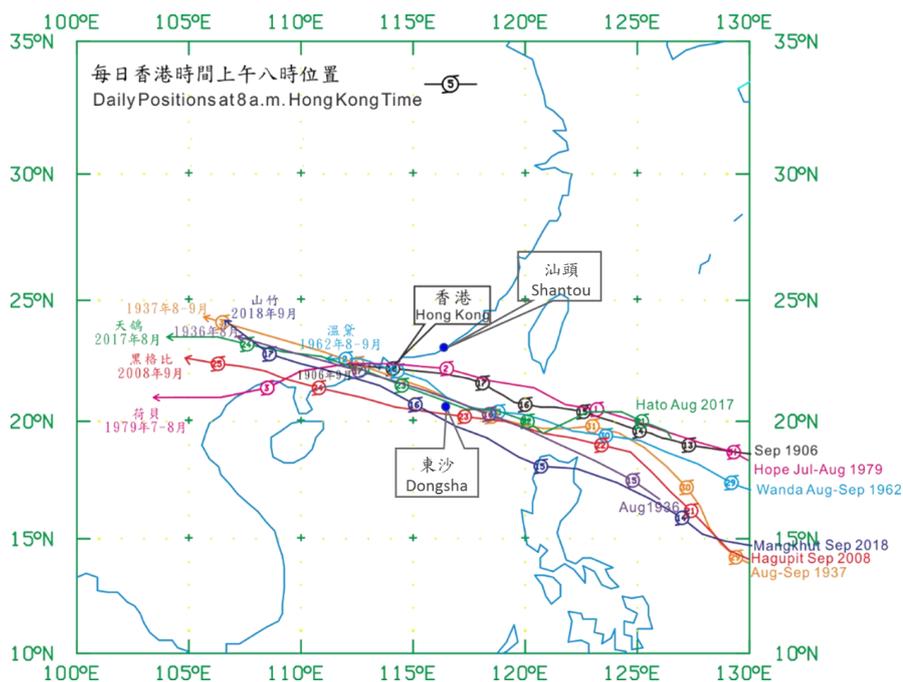
Figure 1. Tracks of the typhoons affecting Hong Kong in 1906, 1936, 1937, Super Typhoon Wanda in 1962, Super Typhoon Hope in 1979, Severe Typhoon Hagupit in 2008, Super Typhoon Hato in 2017 and Super Typhoon Mangkhut in 2018.

Figure 1 shows that typhoons bringing significant storm surge impact to Hong Kong have similar tracks - forming and intensifying into at least typhoon strength over the western North Pacific, moving across the Luzon Strait without making  
50 landfall over the Philippines and Taiwan (except Mangkhut which skirted the northern part of Luzon), approaching the coast of Guangdong and making landfall over or passing to the south of Hong Kong. Typhoons moving across the Luzon Strait without making landfall over the Philippines and Taiwan can maintain their intensity, and making landfall over or passing to the south of Hong Kong will generate onshore winds that bring severe storm surges to the territory.

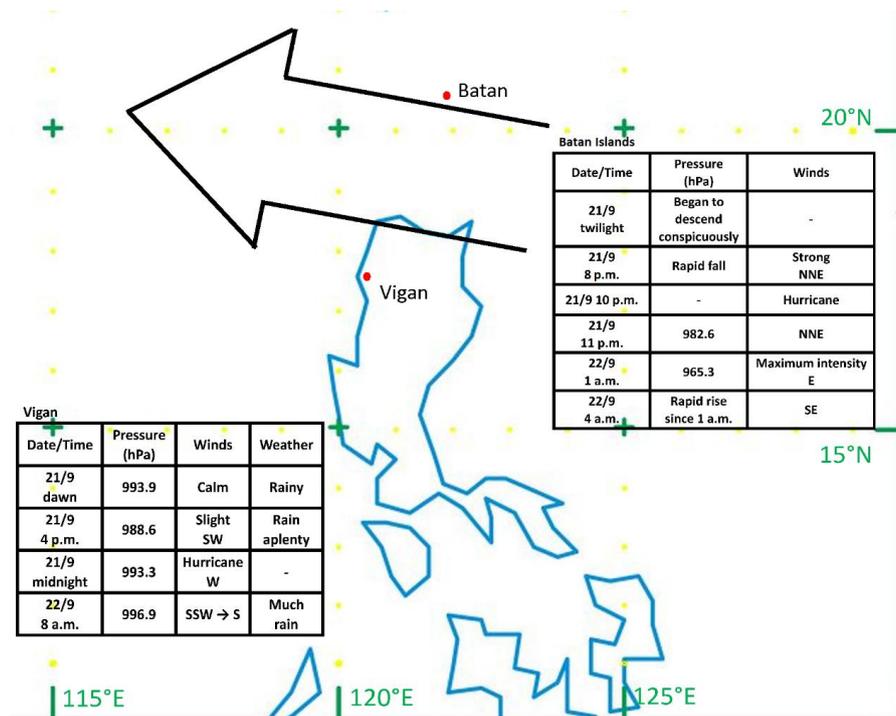
Figure 4. The possible track of Typhoon 1874 moving across the Luzon Strait and the chronological summary of the meteorological observations at Vigan and Batan Islands. Pressure observations had been converted from mmHg to hPa using  $1 \text{ mm Hg} = 1.33322387 \text{ hPa}$  based on the Smithsonian Meteorological Tables, 4<sup>th</sup> revised edition, 1918.

190 Figure 4 shows the geographical location of Vigan and Batan Islands and chronological summary of the meteorological observations at the two locations based on the information in Annex I. It can be seen that Batan Islands and Vigan were affected by hurricane force winds from the east and west respectively at around midnight of 21 September, suggesting that the centre of Typhoon 1874 was passing through the area between Vigan and Batan Islands at about that time. As the pressure recorded at Batan Islands at 1 a.m. on 22 September (724 mmHg

or 965.3 hPa) was much lower than that recorded at Vigan at midnight of 21 September (745 mmHg or 993.3 hPa), the centre of Typhoon 1874 was likely closer to Batan Islands than Vigan and located over the sea area off the coast of northern Luzon during its passage over the Luzon Strait, as indicated by the arrow in Figure 4.

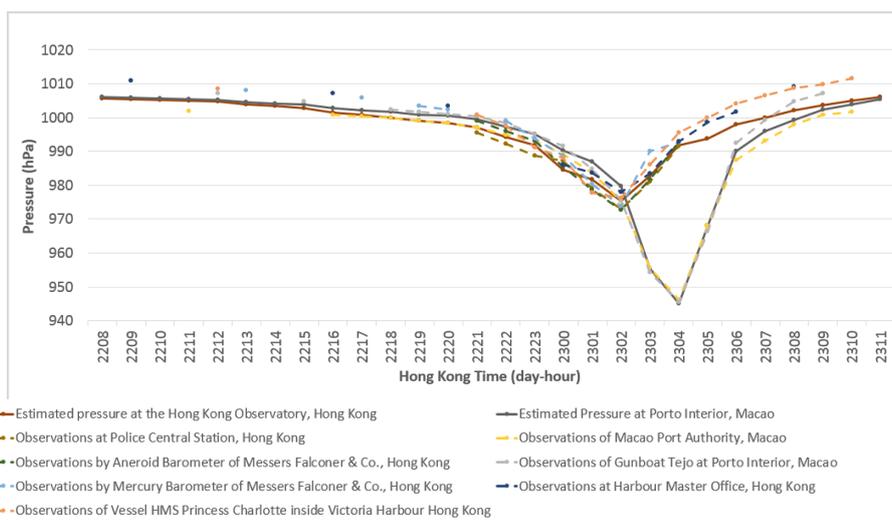
Figure 5. Series plots of pressure observations recorded in various places in Hong Kong and Macao from 8 a.m. on 22 September to 11 a.m. on 23 September 1874 (as listed in Table 2) and the series plots of the atmospheric pressures at Hong Kong (Hong Kong Observatory) and Macao (Porto Interior) during the same period estimated by the Jelesnianski tropical cyclone model based on the reconstructed possible track (as listed in Table 4).

A summary of the pressure observations in Hong Kong and Macao during the passage of Typhoon 1874 extracted from the available historical documents is shown in Table 2. Figure 5 plots the time series of those pressure observations from 8 a.m. on 22 September to 11 a.m. on 23 September 1874. It can be seen that the pressure at Hong Kong reached the minimum of around 975 hPa at 2 a.m. on 23 September while the pressure at Macao continued to fall to a minimum of around 946 hPa at 4 a.m. on 23 September. Furthermore, the pressure readings and pressure falling rate at Hong Kong and Macao were rather close with each other from the evening of 22 September to 2 a.m. on 23 September. This phenomenon revealed that Typhoon 1874 was at a more or less the same distance from Hong Kong and Macao when it approached the Pearl River Estuary during this period.

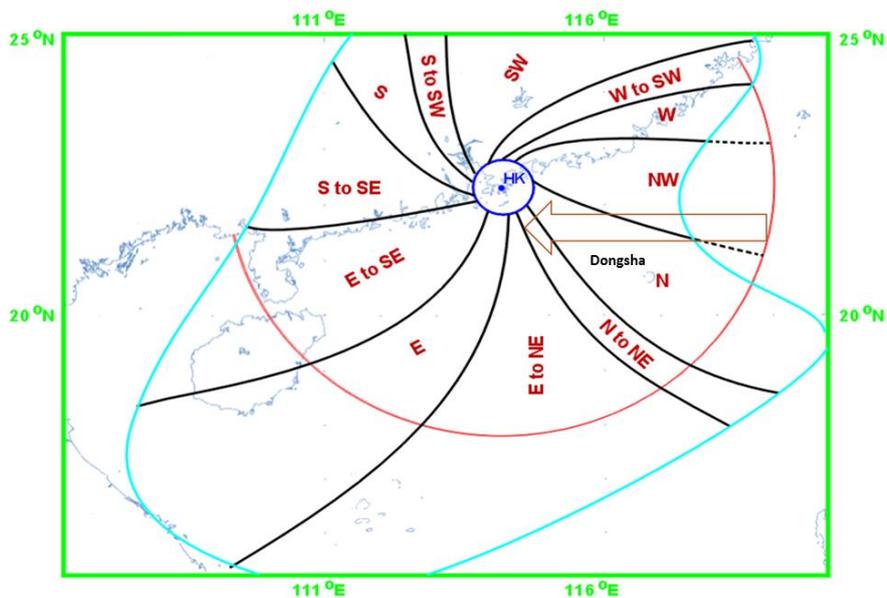
Figure 6. The 12-segment reference diagram showing the correlation between the wind direction at Waglan Island and tropical cyclone position during strong winds or above situations used by the Hong Kong Observatory. The arrow shows a typical track of tropical cyclone that could cause a change of wind direction in Hong Kong similar to that of the passage of Typhoon 1874.

According to the result of a study on the relation between tropical cyclone position and wind direction at Waglan Island (an offshore island over the southeastern part of Hong Kong) during strong winds or above situations using tropical cyclones from 1968 to 2001 (Figure 6, Hong Kong Observatory), the sequence of wind direction change at Hong Kong during the passage of Typhoon 1874 suggested that Typhoon 1874 might most possibly approach Hong Kong from more or less the east and pass to the south of Hong Kong in the small hours on 23 September. This also provided further support for Typhoon 1874 passing to the north of Dongsha during its passage in the northeastern part of the South China Sea.

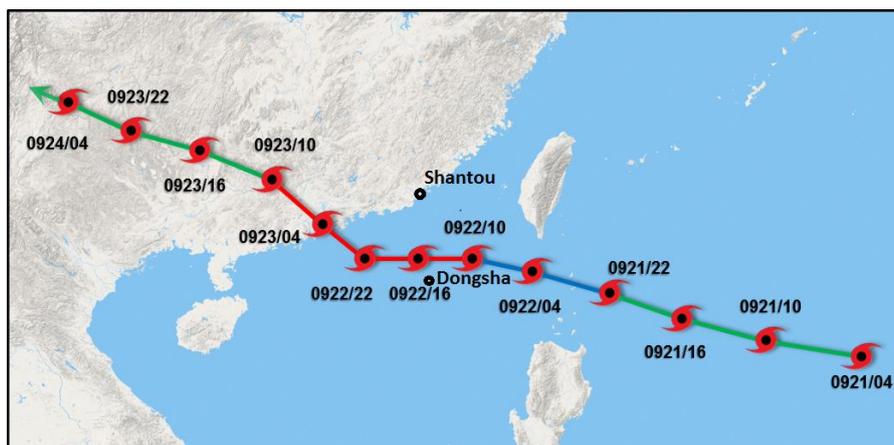
Figure 7 (a). The possible track of Typhoon 1874 passing through the Luzon Strait and moving across the northern part of the South China Sea reconstructed in this study. Locations of Shantou and Dongsha are also shown.

Figure 7 (a) & (b) plot the possible track of Typhoon 1874 from the Luzon Strait to inland western Guangdong reconstructed in this study. In Figure 7(a), the part of the track in red was based on Table 4, the part in blue (in the morning on 22 September) was estimated by interpolation based on the quantitative analysis discussed in preceding session, and the parts in green were arbitrarily extended

The 6-hourly positions, minimum mean sea level pressures near the centre and the radii of maximum winds of the reconstructed track of Typhoon 1874 in Figure 7(a) used for running SLOSH is shown in Table 5. It can be seen that Table 5 has

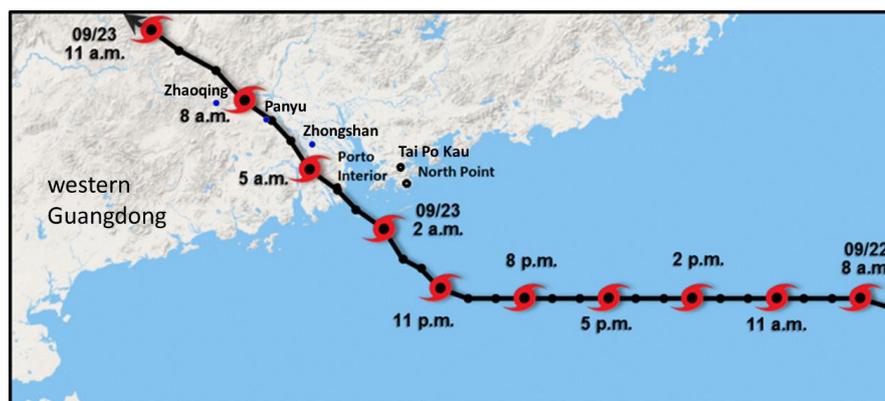
Figure 7 (b). The possible track of Typhoon 1874 moving along the coast of eastern Guangdong and the Pearl River Estuary reconstructed in this study. Locations of the tide gauges at North Point, Tai Po Kau and Porto Interior, and locations of Zhongshan, Panyu and Zhaoqing are also shown.

360 included the position at 10 p.m. on 22 September when Typhoon 1874 started to  
pick up a northwesterly track and the position at 4 a.m. on 23 September when  
the typhoon made landfall at Macao. The topographic and bathymetry  
information in the early 1990's were used for the estimation as no such  
information in 1874 were readily available. The maximum storm surges as  
estimated by SLOSH were 2.83 m (at 4:10 a.m. on 23 September) at North Point in  
the Victoria Harbour and 2.83 m (at 4:00 a.m. on 23 September) at Tai Po Kau in  
the northeastern part of Hong Kong where the tide gauges operated by the Hong  
Kong Observatory since the 1950s and 1960s respectively were located. In Macao,  
the maximum storm surge as estimated by SLOSH was 2.80 m (at 4:00 a.m. on 23  
September) at Porto Interior where the tide gauge operated in Macao were  
370 located. Locations of these three tide gauges are also marked in Figure 7 (b).

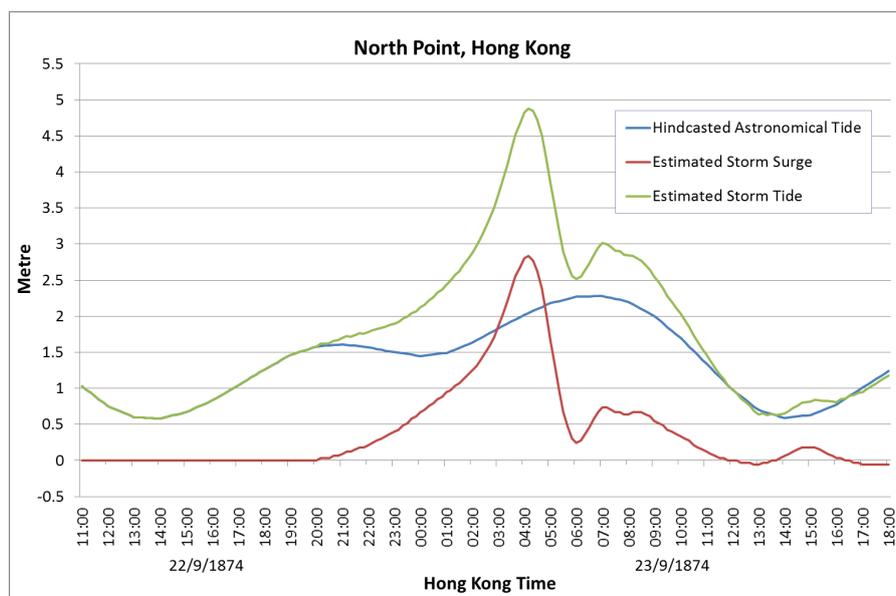
Figure 8. Time series of the astronomical tide, estimated storm surge and estimated storm tide from 11 a.m. on 22 September to 6 p.m. on 23 September 1874 at North Point in Hong Kong.

Combining the estimated storm surges and hindcasted astronomical tides, the peak storm tides were estimated to be 4.88 m above Hong Kong Chart Datum (at 4:10 a.m. on 23 September) at North Point, 4.95 m above Hong Kong Chart Datum (at 4:00 a.m. on 23 September) at Tai Po Kau and 5.37 m above Macao Chart Datum (at 4:00 a.m. on 23 September) at Porto Interior in Macao. Figure 8, 9 and 10 plot the time series of the hindcasted astronomical tide, estimated storm surge and storm tide at North Point (Hong Kong), Tai Po Kau (Hong Kong) and Porto Interior (Macao) respectively from 11 a.m. on 22 September to 6 p.m. on 23 September 1874.

It can be seen that the hindcasted astronomical tide at North Point showed a low tide from midnight to around 2 a.m. on 23 September which was consistent with what the Harbour Master mentioned in his report in the Hong Kong Government Gazette of 17 October 1874 (The Hong Kong Government, 1874) – “Although, according to ordinary calculation it should have been low water at two o’clock”. Furthermore, the difference between the storm tide of 3.69 m at 3 a.m. and the astronomical high tide of 2.28 m at around 6:30 a.m. on 23 September at North Point was slightly lower than but comparable with the qualitative description of the rise in sea levels as recorded in the report of the Harbour Master in the Hong Kong Government Gazette of 17 October 1874 (The Hong Kong Government, 1874) – “By three, the water had risen to from five to six feet above its high water level”. In Macao, the difference between the maximum storm tide of 5.37 m at 4 a.m. and the astronomical high tide of 2.77 m at around 6 a.m. on 23 September at Porto Interior in Macao was slightly higher than but still considered comparable with the qualitative description of rise in sea levels as recorded in the publication “O Maior Tufao De Macau - 22 e 23 de Setembro de 1874” by Father Manuel Teixeira (1974) – “storm surge which caused severe flooding of up to 7 feet above the high tide level”.

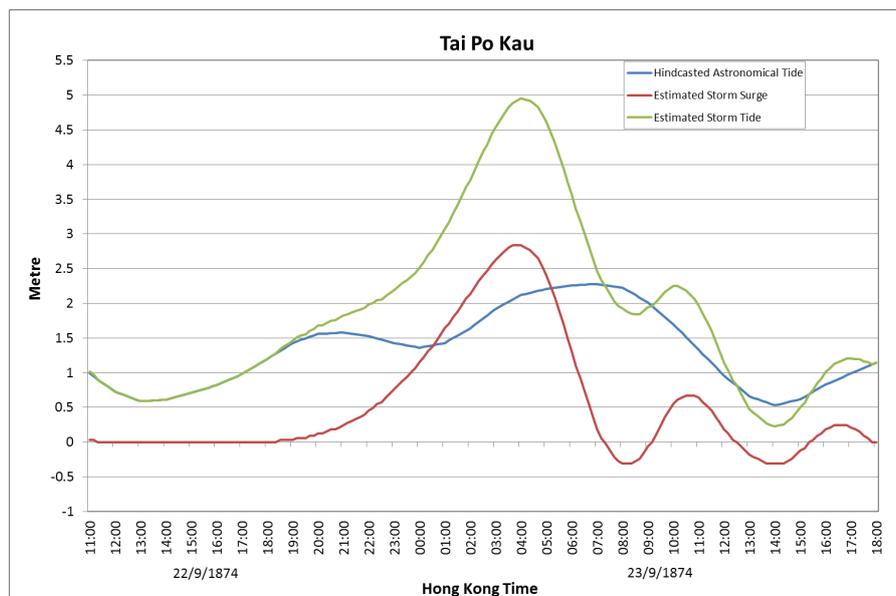
Figure 9. Time series of the astronomical tide, estimated storm surge and estimated storm tide from 11 a.m. on 22 September to 6 p.m. on 23 September 1874 at Tai Po Kau in Hong Kong.

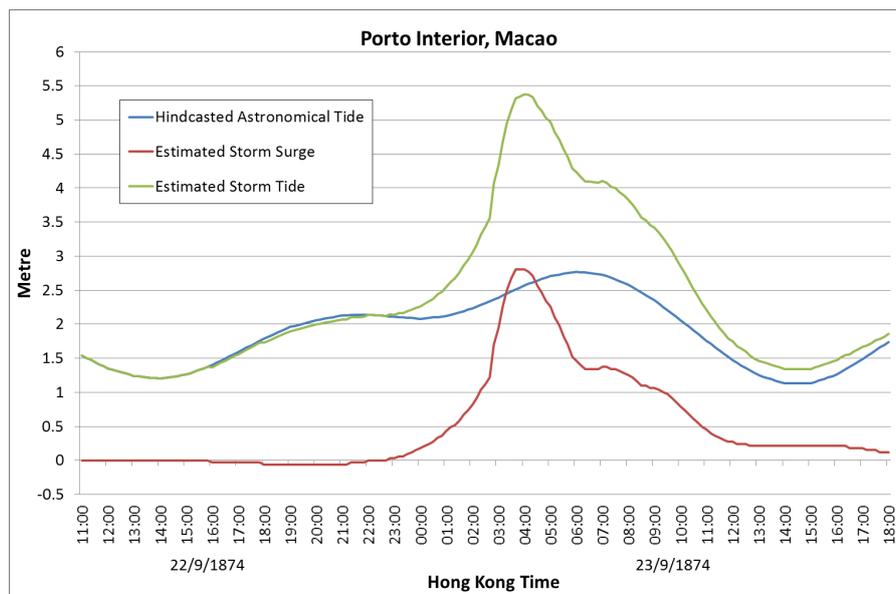
Figure 10. Time series of the astronomical tide, estimated storm surge and estimated storm tide from 11 a.m. on 22 September to 6 p.m. on 23 September 1874 at Porto Interior in Macao.
